# 1964 Great Alaska Earthquake—A Photographic Tour of Anchorage, Alaska

Open-File Report 2014–1086

By Evan E. Thoms, Peter J. Haeussler, Rebecca D. Anderson, and Robert G. McGimsey

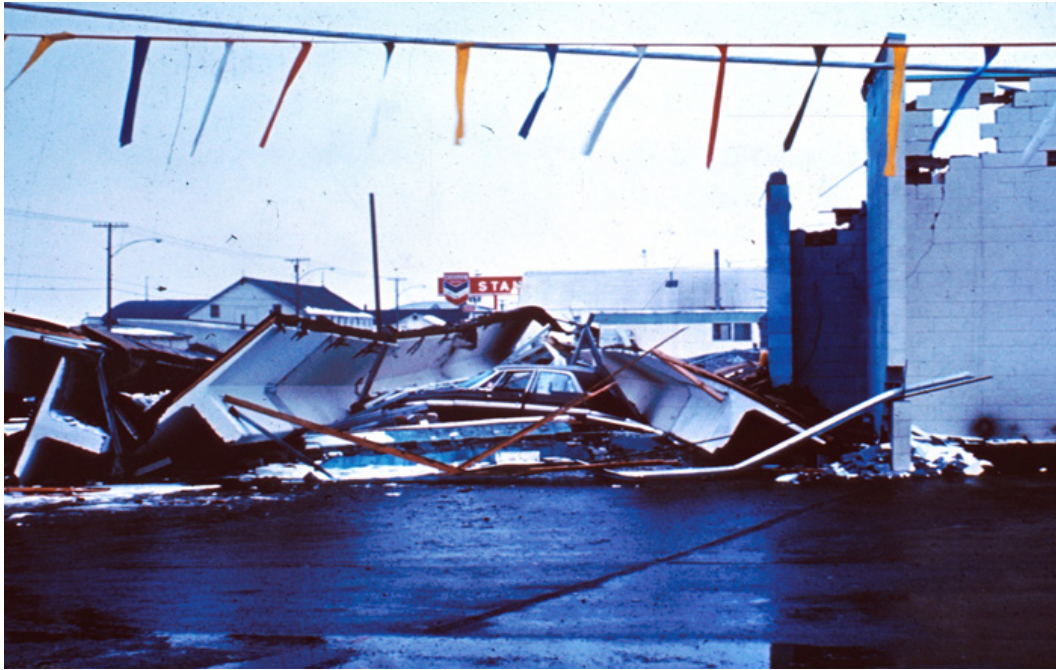
“The one-story 5th Avenue Chrysler Center just north of Merrill Field was a total loss. It had a precast- and prestressed-concrete T-beam roof supported by concrete-block walls. The front of the building collapsed and the T-beam roof fell in on the showroom. The hollow-core concrete block side walls failed at the rear corners of the building” (Hansen, 1965, p. A24) (fig. 3).

**Figure 3.** The 5th Avenue Chrysler Building, Anchorage, Alaska, 1964. (Photograph from U.S. Geological Survey Photographic Library, ID aeq00025.)

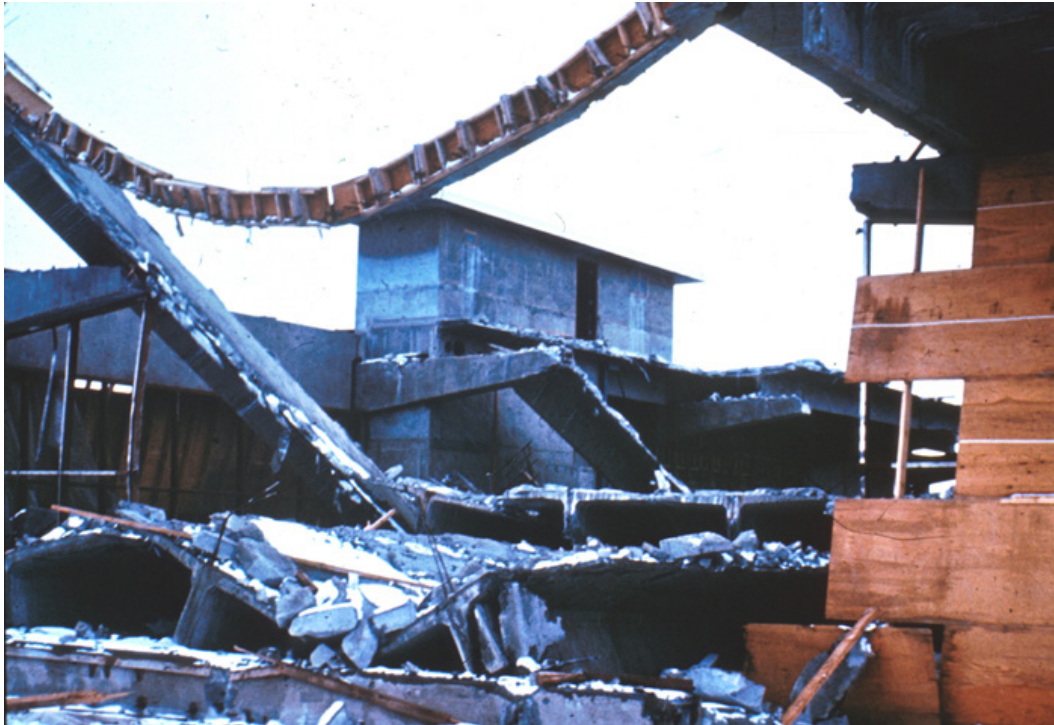
“The one-story Alaska Sales and Service Building on East 5th Avenue at Medfra Street was under construction but was structurally almost complete at the time of the earthquake; it was a total loss. Collapse is attributed chiefly to failure of melded connections between T-shaped precast-concrete columns and roof beams, caused either by the breaking of welds or tearing out of bar inserts. The exterior precast-concrete walls of the building partly collapsed when the roof gave way” (Hansen, 1965, p. A23; fig. 4).

Figure 4. The Alaska Sales and Service Building, Anchorage, Alaska, 1964. (Photograph from U.S. Geological Survey Photographic Library , ID aeq00024.)

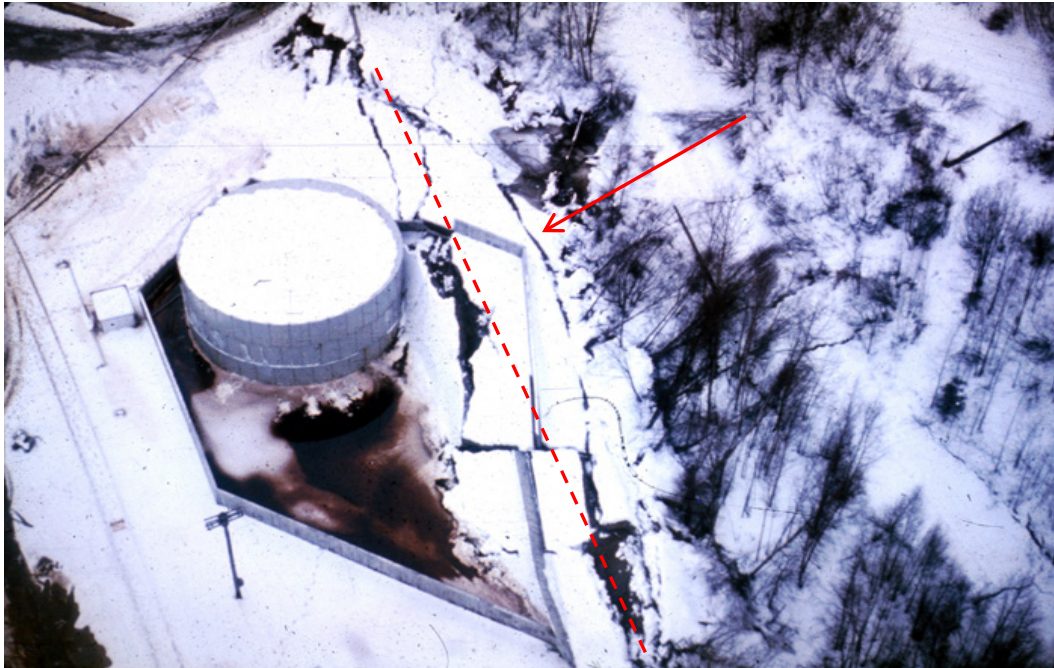
Like a rug being pushed along a floor, landslides can cause folding of the ground in front of them as they slide. A fuel tank (fig. 5) at the toe of the Native Hospital Slide (stop 4) was damaged by this type of folding because of shortening when the bluff upslope failed and slid downhill (Hansen, 1965). Deformation like this also caused damage to buildings at the toes of the 4th Avenue and L Street Slides (Hansen, 1965, p. A23).

**Figure 5.** Fuel tank damaged by compressional folding at the toe of the Native Hospital Slide, Anchorage, Alaska, 1964. Red arrow indicates the direction of push from the landslide and the dashed red line indicates the crest of the resulting fold in the ground. (Photograph from U.S. Geological Survey Photographic Library, ID aeq00053.)

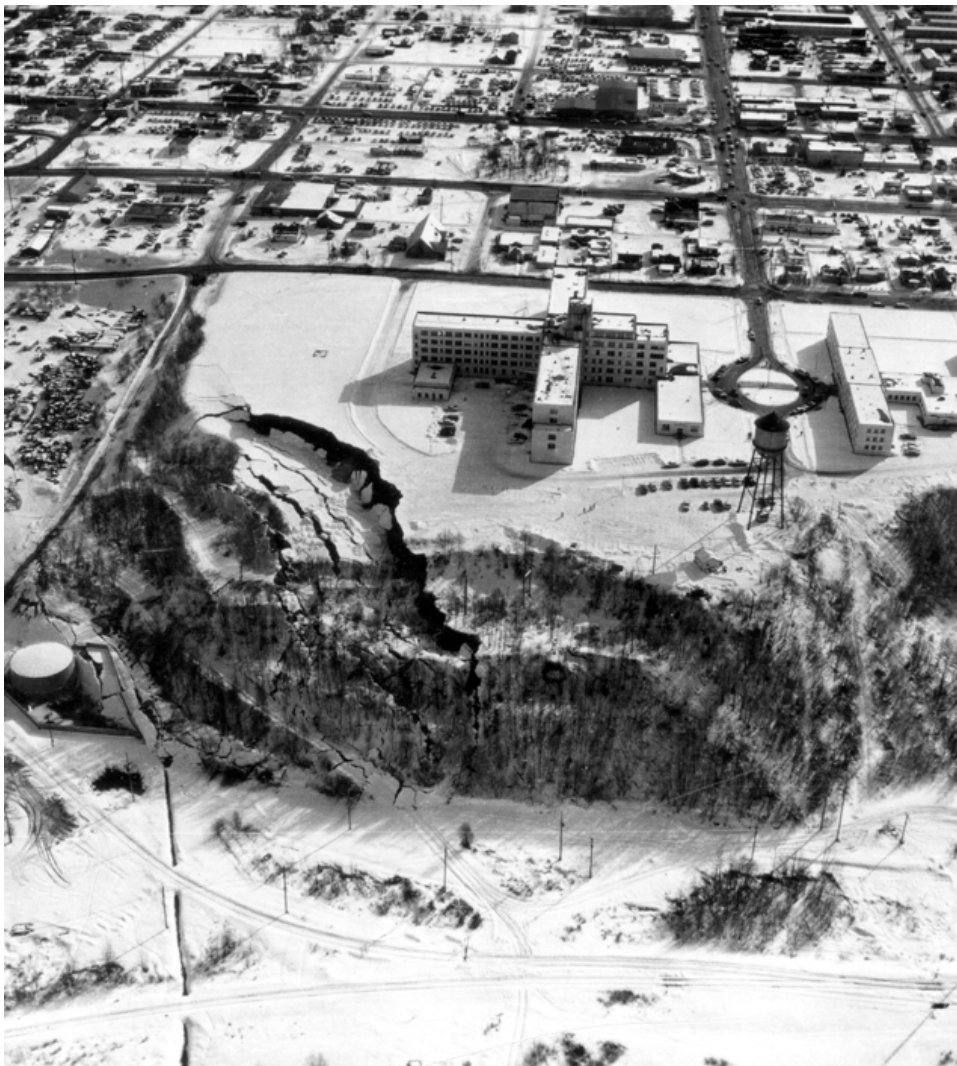
“The Native Hospital Slide, or 1st Avenue Slide as it has occasionally been called, disrupted part of the grounds of the Alaska Native Service Hospital and wrecked a fuel-storage tank at the foot of the bluff. Although it was a small slide and not a very destructive one, it was of unusual scientific interest because of its clear portrayal of repeated translatory landsliding in the same area. The slide of March 27, 1964, transected an earlier slide of identical habit and exposed the older graben in full cross section in the headward scarp of the present graben. This site of failure, therefore, seems to answer the question as to whether natural remolding and consolidation of the clay after sliding is sufficient in itself to forestall further sliding—it obviously was not, in the Native Hospital Slide. Most other slide areas at Anchorage and vicinity also presented evidence of multiple sliding, but none did it as clearly as the Native Hospital Slide” (Hansen, 1965, p. A49; fig. 6).

**Figure 6.** Oblique aerial view looking south of the Native Hospital Slide and the former Alaska Native Service Hospital, Anchorage, Alaska, 1964. The damaged fuel tank from Stop 3 (fig. 5) can be seen below the middle of the left margin of the photograph. (Photograph from U.S. Geological Survey Photographic Library, ID ake00065.)

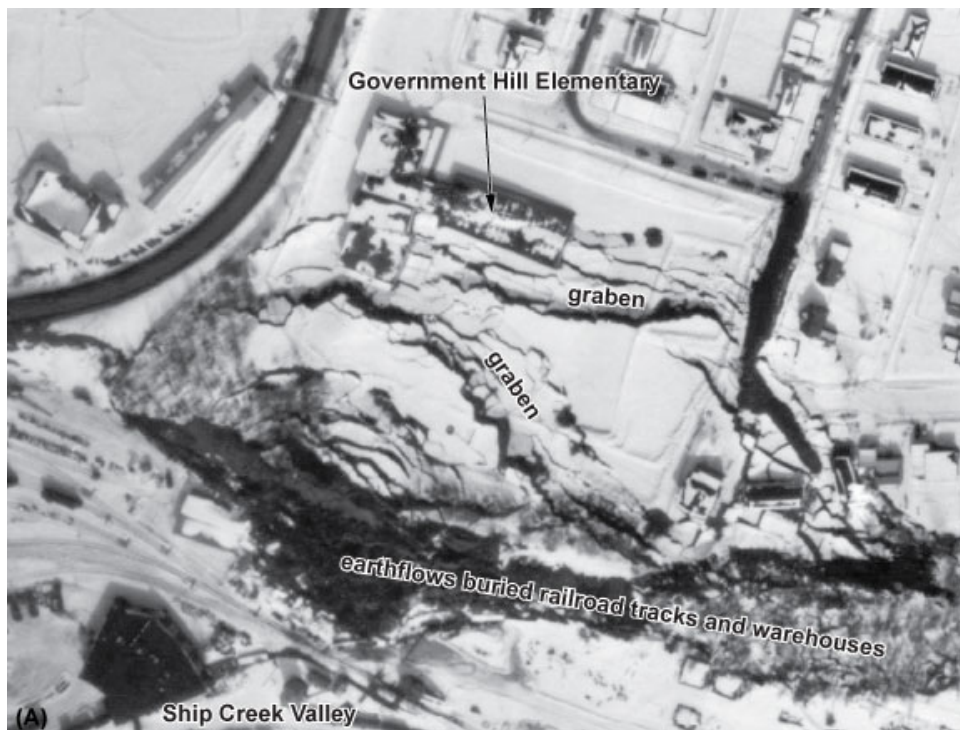
The Government Hill Elementary School was destroyed when part of the bluff on which it was built slid southward about 35 feet toward Ship Creek and caused lowering of the ground in the form of two major troughs, or grabens, and many smaller fractures (fig. 8; Hansen, 1965, p. A54). The surface along where the sliding occurred was within a sensitive facies of the underlying Bootlegger Cove Formation (Hansen, 1965, p. A58). Because school was not in session (the earthquake occurred in the evening and March 27, 1964, fell on Good Friday, observed as a holiday in Alaska at the time) and the building was empty, no lives were lost (Hansen, 1965). The school was rebuilt two blocks to the north in 1965 and the former school site was developed into a park in 1985 (Municipality of Anchorage, 2013; fig. 9).

**Figure 8.** Annotated March 30, 1964, aerial photograph of the Government Hill Slide, Anchorage, Alaska, 1964. (Photograph taken by Air Photo Tech.)

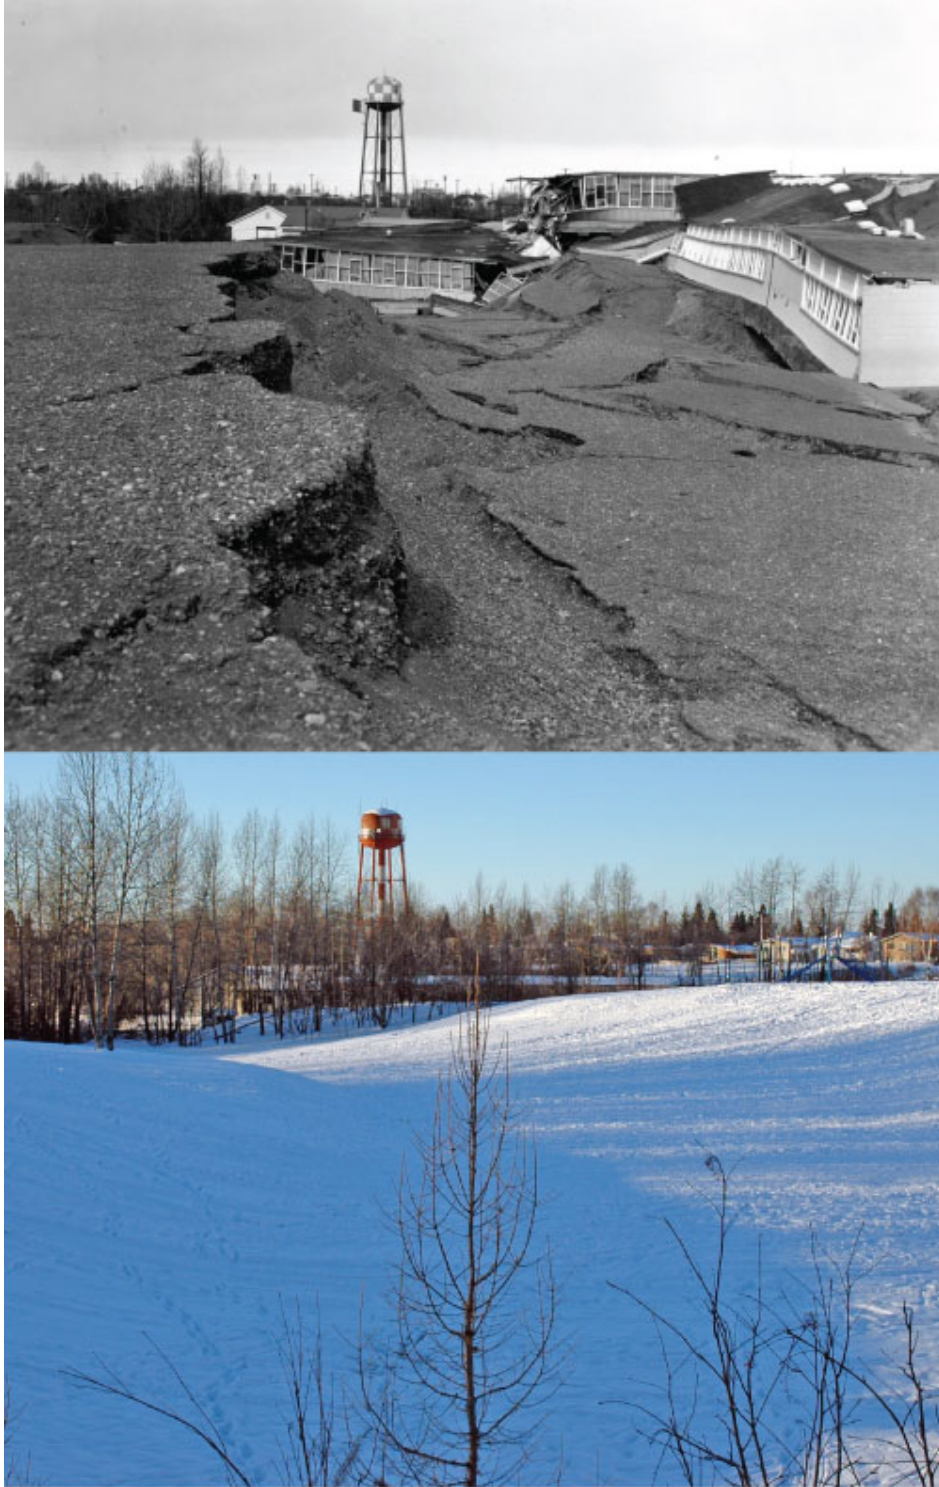
**Figure 9.** Comparison photographs taken from the same location at the Government Hill Slide area, Anchorage, Alaska, in 1964 (top) and 2013 (bottom) looking west near the middle of the uppermost occurrence of the word “graben” in figure 8. The same watertower is visible in the background of both images. (Top photograph from U.S. Geological Survey Photographic Library, ID ake00067; bottom photograph taken by R.G. McGimsey, U.S. Geological Survey, 2013.)

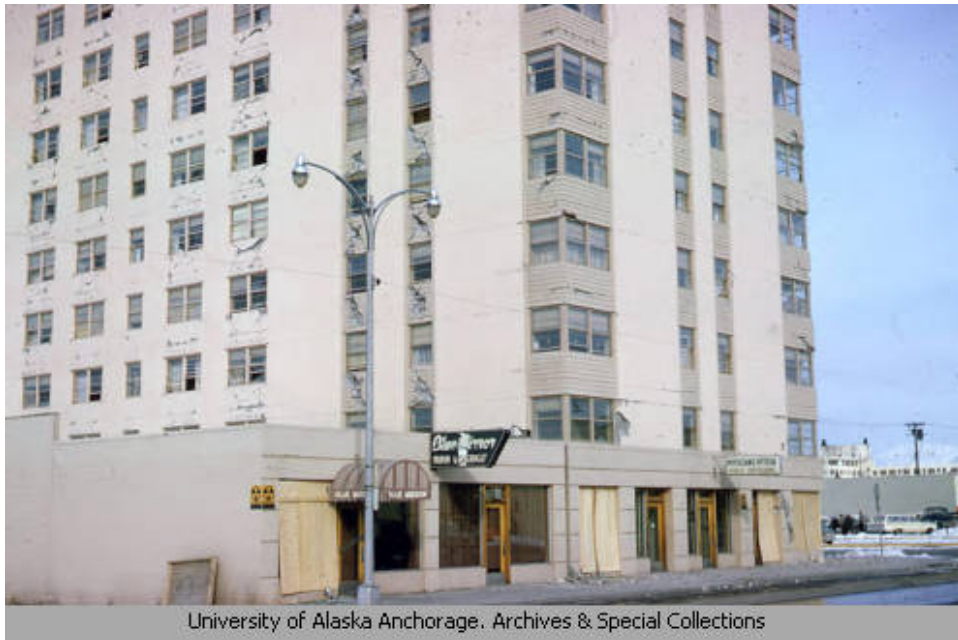
The McKinley Tower (historically known as the Mount McKinley Building and the MacKay Building) and the Inlet Tower (historically known as the 1200 L Street Building) (Stop 19) are identical 14-story apartment buildings completed in 1951 about 1 mi apart. Both towers sustained similar damage, the most obvious being classic x-shaped shear cracks in the exterior stucco below many of the windows (fig. 10; Hansen, 1965, p. A26). During retrofitting, beginning in the late 1990s, structural elements in the McKinley Tower building were reinforced with an epoxy-saturated carbon fabric in order help meet seismic building codes (Martin, 2005).

**Figure 10.** Damage to the McKinley Tower (Mount McKinley Building at the time of the earthquake), Anchorage, Alaska, 1964. Compare the x-shaped cracks below the windows with those on the Inlet Tower (Stop 19). (Photograph from Judith and Malcolm McDonald papers, Archives and Special Collections, Consortium Library, University of Alaska Anchorage ID uaa-hmc-0619-s2-f22-20.)

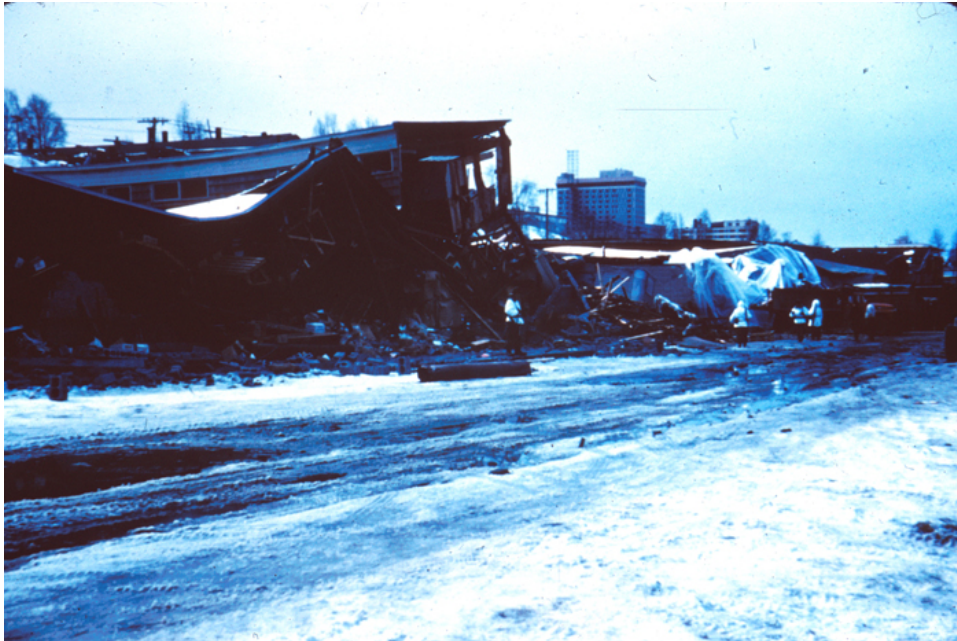
While tensional fractures and deep grabens characterized the 4th Avenue Slide between 2nd and 4th Avenue, warehouses along 1st Avenue were heavily damaged by compressional deformation at the toe of the slide (Hansen, 1965, p. A23; fig. 11). This area remains an important distribution center for goods, but the risk of damage similar to that incurred in 1964 is ostensibly reduced by the construction of Buttress Park (Stop 11).

**Figure 11.** View looking southwest from 1st Avenue of warehouses damaged by compressional deformation at the toe of the 4th Avenue Slide, Anchorage, Alaska, 1964. The Westward Hotel (Stop 13) can be seen in the background. (Photograph from U.S. Geological Survey Photographic Library, ID aeq00051.)

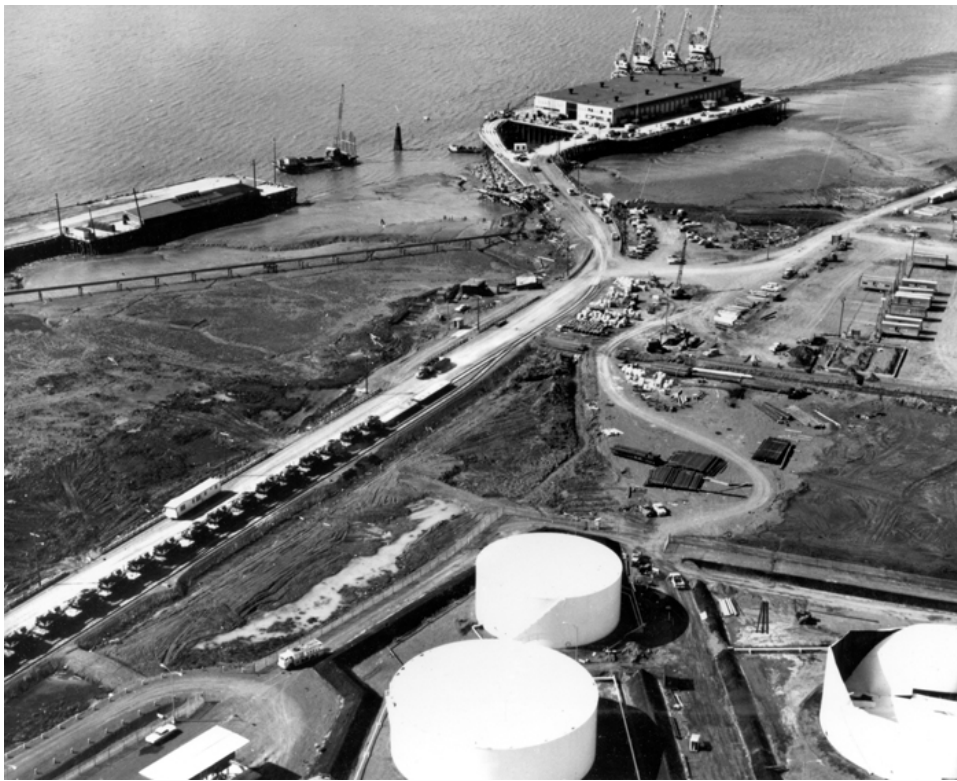
“Much of the damage in the Port of Anchorage area was caused by ground displacements along fractures, but some damage is attributable to direct seismic shaking. The main pier lurched laterally 5 to 19 inches. Large longitudinal cracks and several transverse ones opened up, and the walls of several buildings were cracked. All four gantry cranes were damaged. Steel piles penetrated the deck of a subordinate pier. Approach roads and railroads settled as much as 18 inches. Two cement-storage tanks were toppled, one at the property of the Permanente Cement Co. at the entrance to the U.S. Army Dock and one at the Alaska Aggregate Corp. facility just north of Ship Creek. Oil-storage tanks in the dock area were mostly superficially damaged, but some tanks were bulged outward at the bottom, probably by rocking and pounding back and forth as the contents sloshed to and fro” (Hansen, 1965, p. A27; fig. 12).

**Figure 12.** Anchorage municipal wharf area at low tide, shortly after the earthquake, Anchorage, Alaska, 1964. The main dock was slightly damaged, but the older U.S. Army dock (upper left) was ruined. Vibration and ground fractures damaged some structures in the port area, including the fuel tank seen in the lower right. (Photograph from U.S. Geological Survey Photographic Library, ID ake00243.)

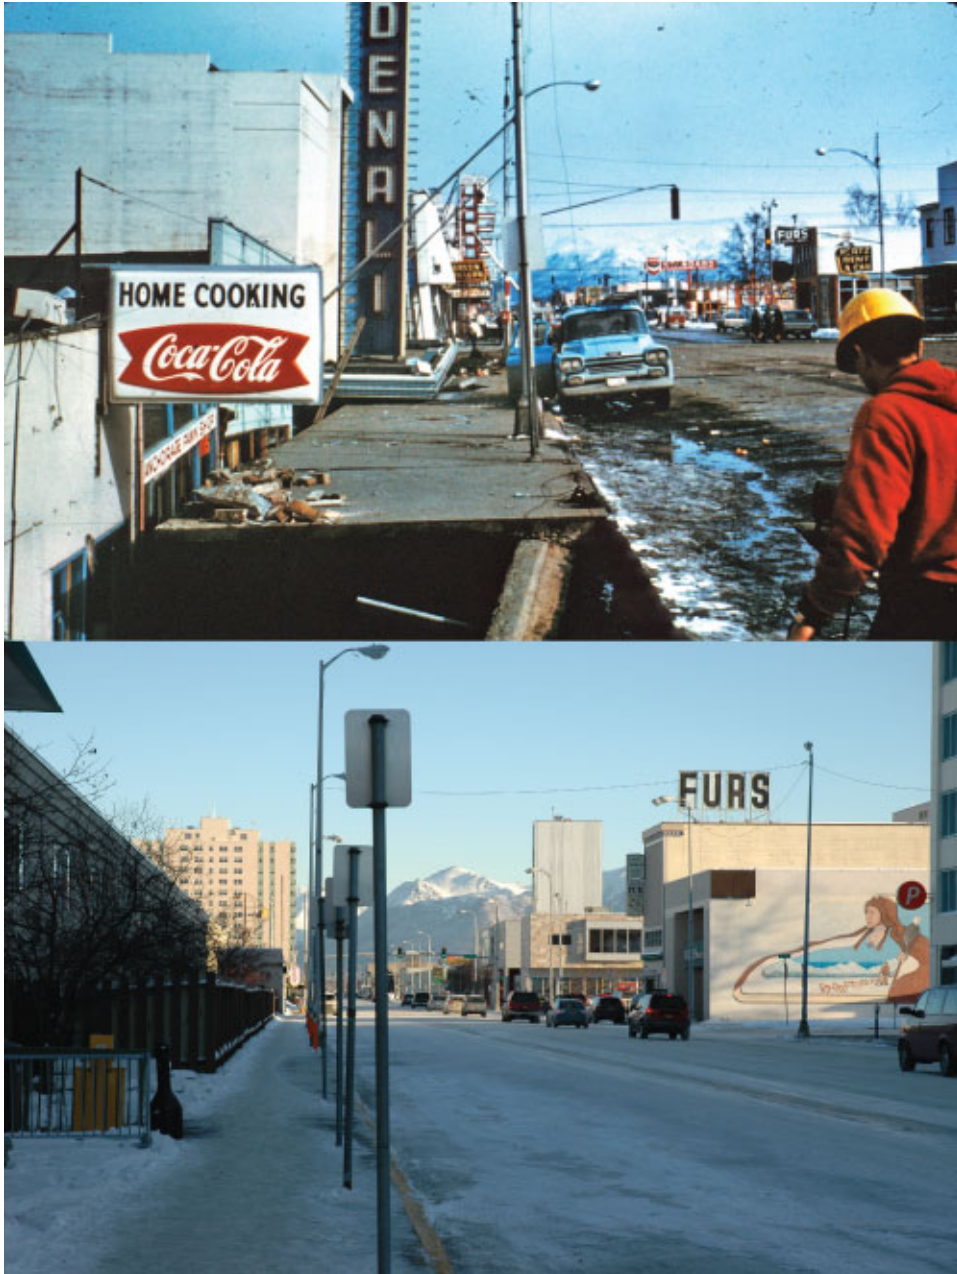
“The 4th Avenue Slide involved all or parts of 14 city blocks in a roughly oval area of about 36 acres, containing perhaps 2 million cubic yards of earth, centered at the northern side of downtown Anchorage. It was bounded headward on the south by 4th Avenue, on the west by E Street, on the north approximately by 1st Avenue, and on the east somewhat indefinitely by Barrow Street. Its length north to south in the direction of slippage was about 1,050 feet; east to west it was about 1,800 feet across. Strong fracturing and related ground displacements extended 1-1/2 blocks (about 450 feet) or so south of the slide proper, where considerable damage was inflicted on buildings, streets, and sidewalks. Minor displacements extended as far south as 600 feet. Eyewitnesses reported that sliding began about 2 minutes after the earthquake started and stopped about the same time as the earthquake” (Hansen, 1965, p. A41; figs. 14, 15, and 16).

**Figure 14.** Comparison photographs taken from the same location on 4th Avenue about 1 block east of the main area of damage, Anchorage, Alaska. In 1964 (top), the ground just to the left of the sidewalk dropped about 8 feet bringing the marquee of the Denali Theater down to street-level. (Top photograph from U.S. Geological Survey Photographic Library, ID aeq00046, 1964; bottom photograph taken by R.G. McGimsey, U.S. Geological Survey, 2013.)

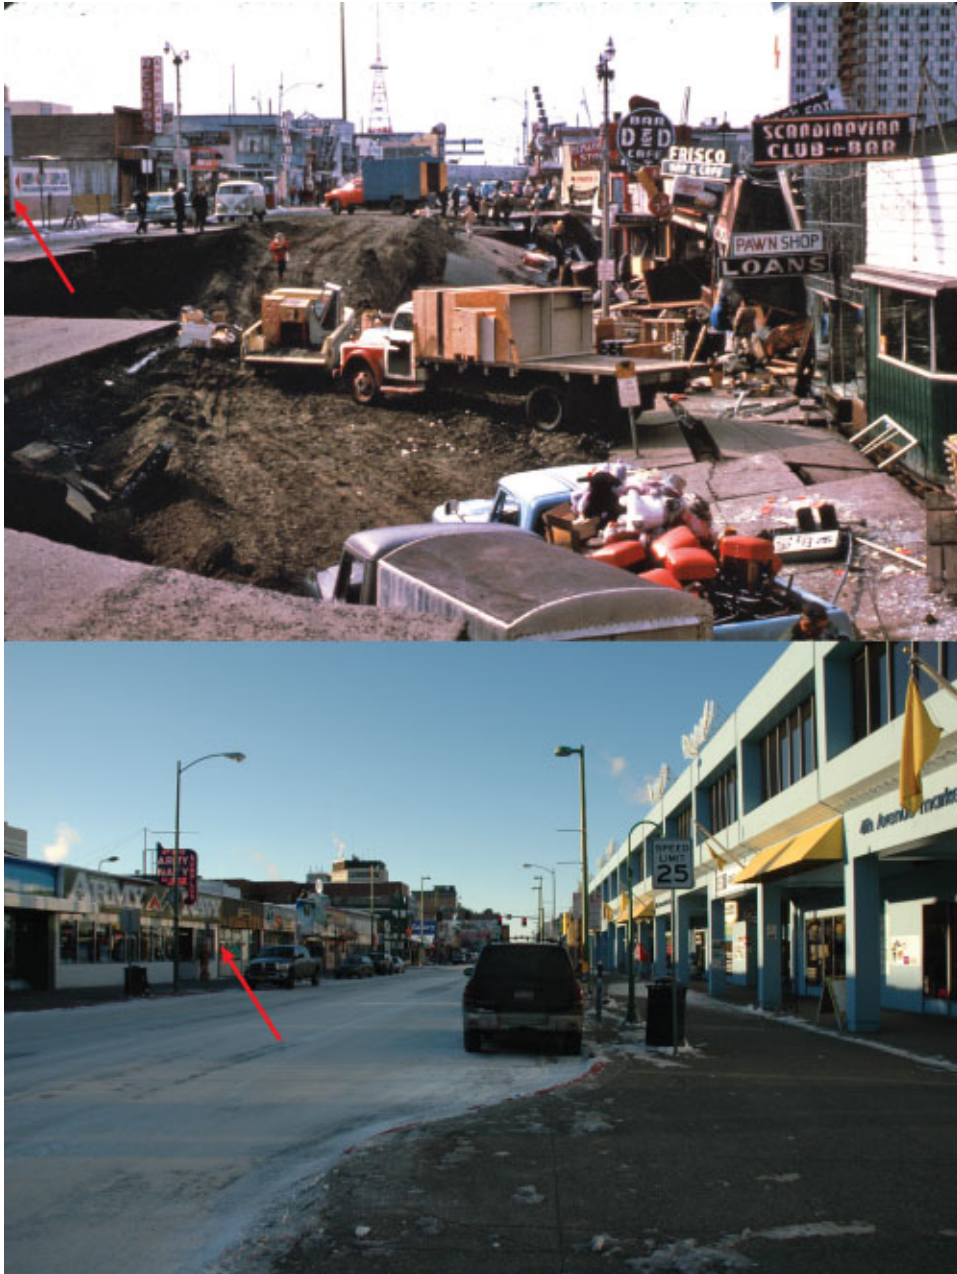
**Figure 15.** Comparison photographs taken from the same location on 4th Avenue near the intersection with C Street and looking west. Red arrows point to the west wall of the Army Navy store in both images. (Top photograph [1964] from U.S. Geological Survey Photographic Library, ID aeq00045; bottom photograph [2013] taken by R.G. McGimsey, U.S. Geological Survey, 2013.)

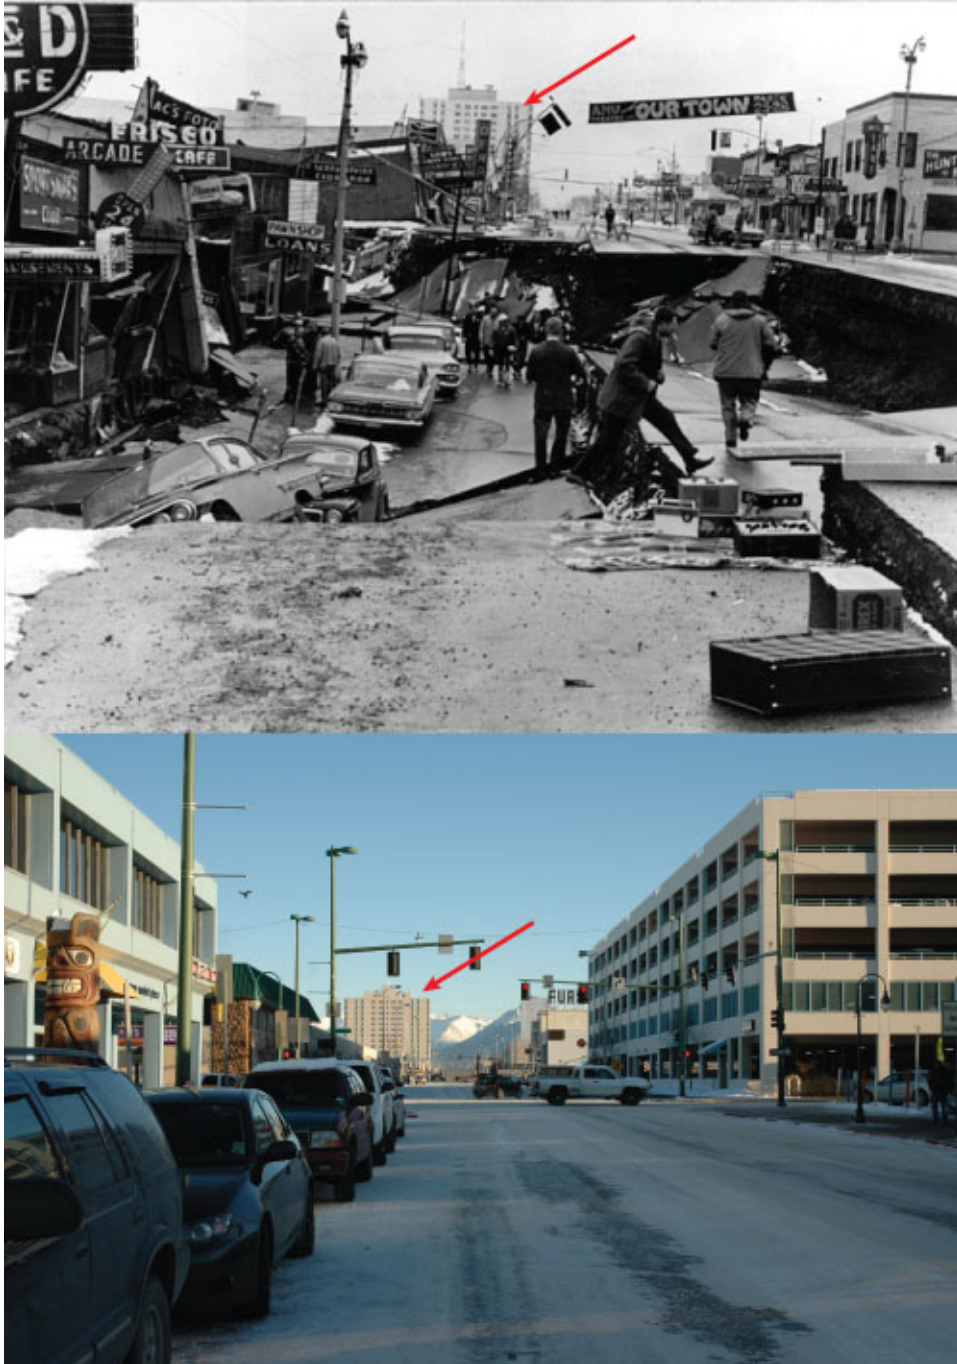
**Figure 16.** Comparison photographs taken from the same location on 4th Avenue looking east through the intersection with C Street, Anchorage, Alaska. Red arrows point to the McKinley Tower (Stop 6) in both images. (Top photograph [1964] taken by U.S. Army, U.S. Geological Survey Photographic Library, ID ake00144; bottom photograph [2013] taken by R.G. McGimsey, U.S. Geological Survey.)

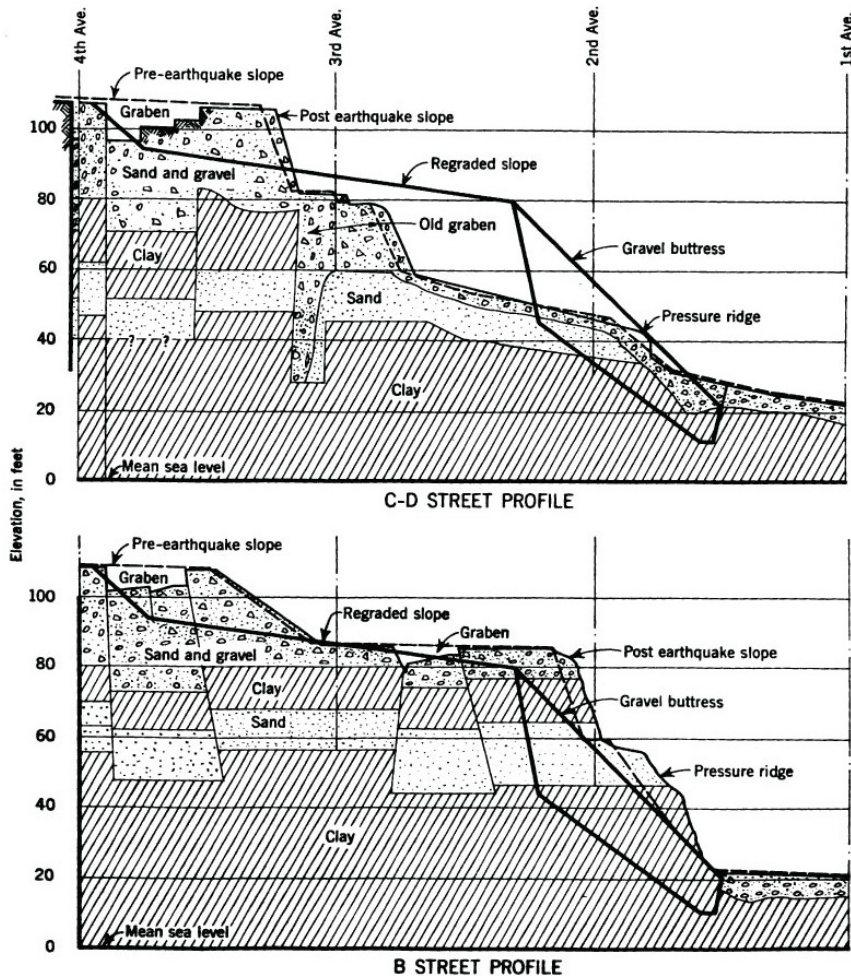
Figure 17. Figure 4 from Long and George (1966), showing cross-section views of the 4th Avenue Slide and the post-earthquake design of the stabilizing gravel buttress. (Used with permission from American Society of Civil Engineers.)

Much of the 4th Avenue Slide area north of 3rd Avenue has been re-graded since the earthquake and turned into Buttress Park. The north-facing slope dropping into Ship Creek has been reinforced at its toe with a buried gravel buttress, giving the park its name (fig. 17). Details of the design can be found in Long and George (1966).

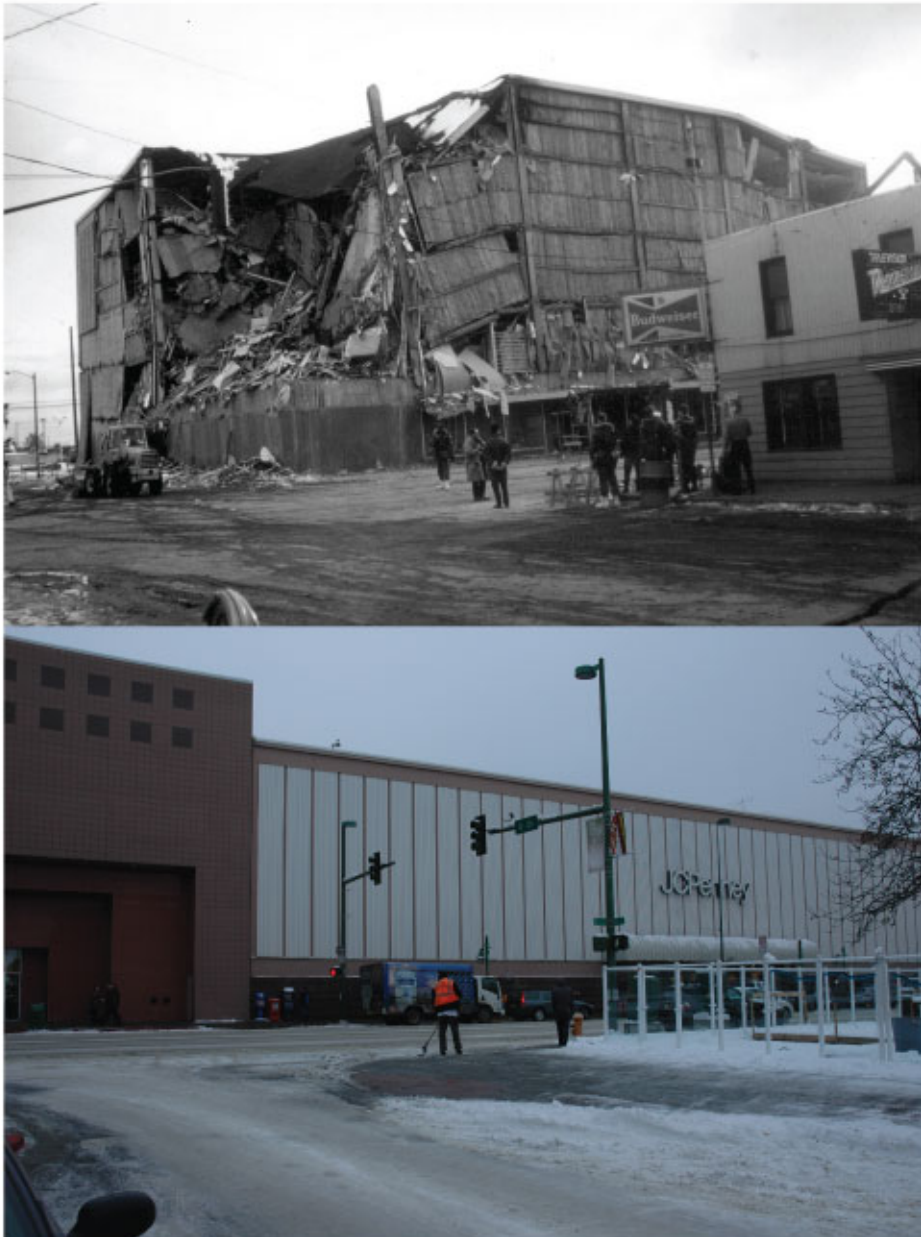
At the time of the earthquake, the J.C. Penney store was five stories tall. The building was damaged beyond repair and torn down (figs. 18 and 19). The principal cause of damage is attributed to rotational motion of the foundation which caused the shearing of various support walls throughout the building (Hansen, 1965, p. A26). At least one death occurred when the north wall of the building fell on a parked car as the owner was attempting to move it to safety (Hansen, 1965, p. A27).

**Figure 18.** Comparison photographs of the J.C. Penney Building from D Street looking southwest, Anchorage, Alaska. (Top photograph [1964] taken by George Plafker, U.S. Geological Survey Photographic Library, ID ake00055; bottom photograph [2013] taken by R.G. McGimsey, U.S. Geological Survey.)

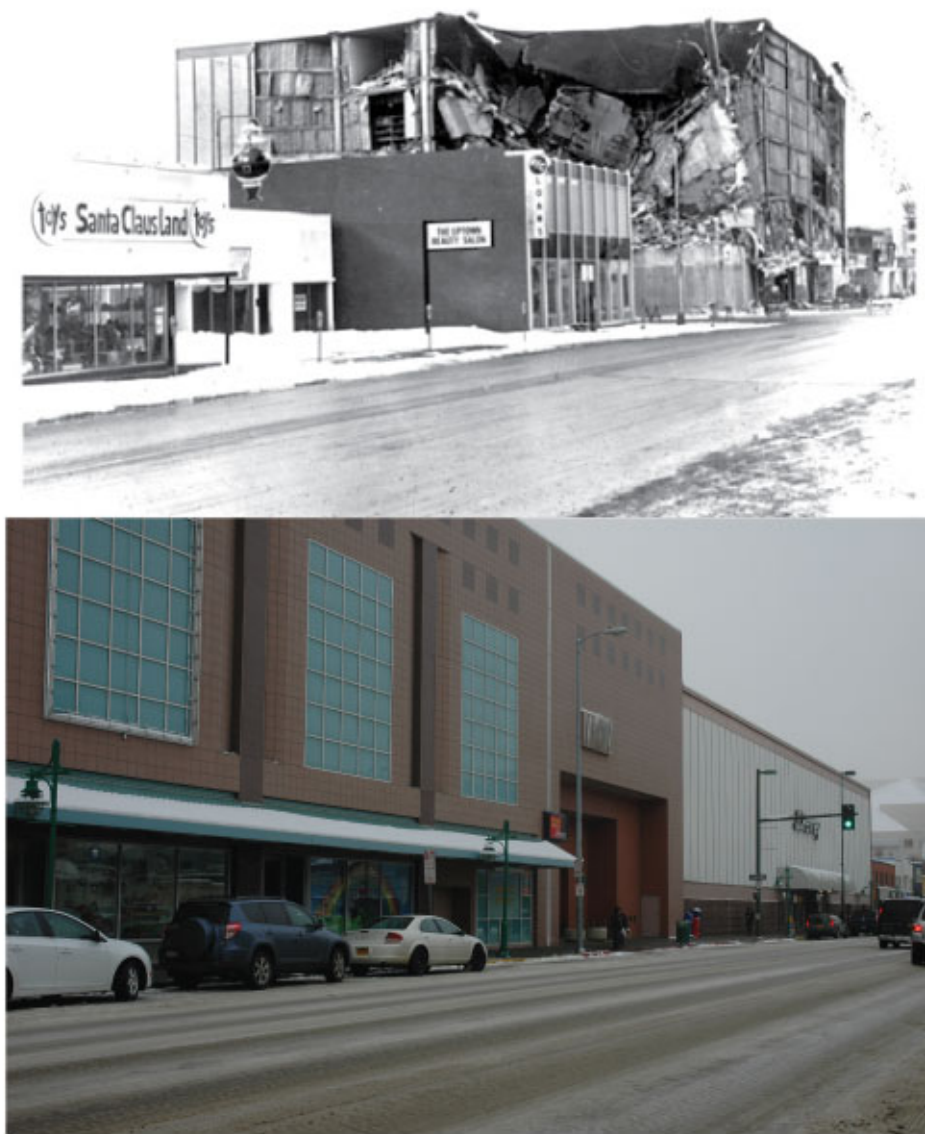
**Figure 19.** Comparison photographs of the J.C. Penney Building from 5th Avenue looking west, Anchorage, Alaska. (Top photograph [1964] taken by U.S. Geological Survey; bottom photograph [2013] taken by R.G. McGimsey, U.S. Geological Survey.)

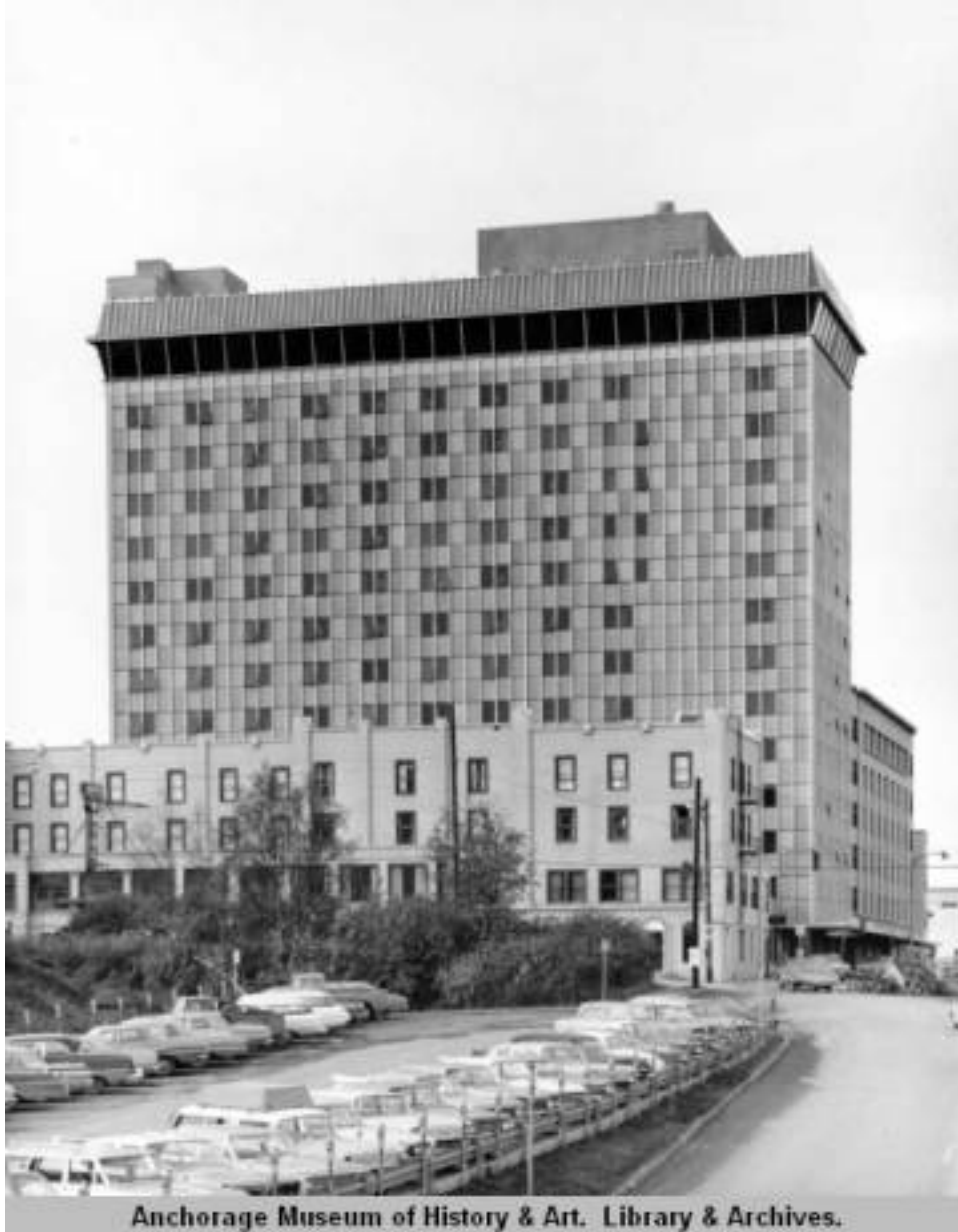
There was little visible damage to the 14-story Westward Hotel, but damage to the interior structural elements was severe (Hansen, 1965, p. A23; fig. 20). The building was repaired, expanded to the west in the 1980s, and is now known as the Hilton Anchorage West Tower (Tundra Times, 1984).

**Figure 20.** View looking east in late 1964 of the Westward Hotel. The lower building in the foreground sits where the Hilton Anchorage East Tower is presently located (2014). (Photograph from Alaska's Digital Archives, Ward Wells Collection, ID AMRC-wws-4231-1.)

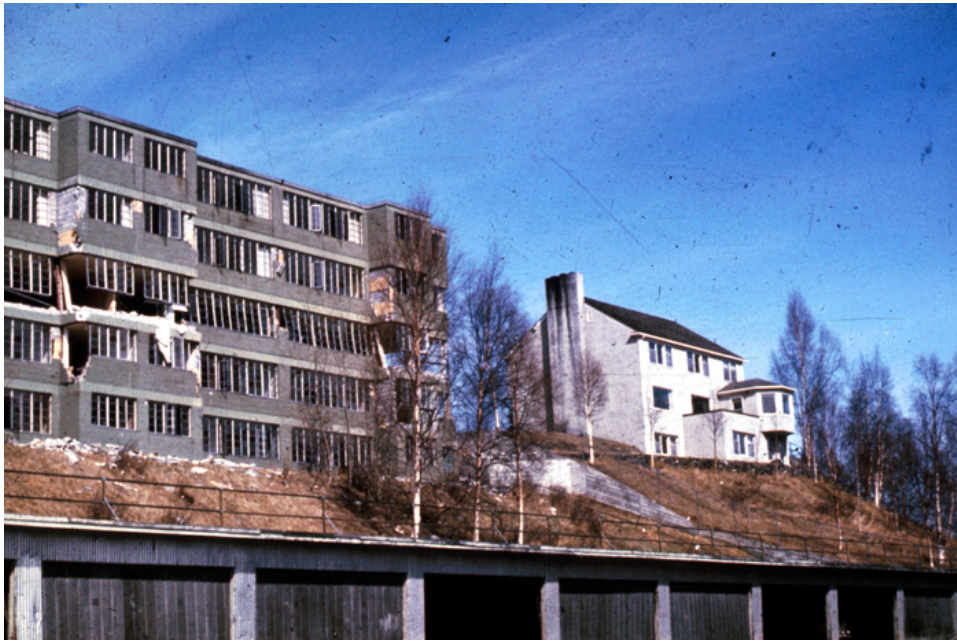
“The Hillside Apartments were on the south side of 16th Avenue between G and H Streets on a bluff overlooking Chester Creek. They were damaged beyond repair and have since been dismantled. This was a split-level building, five stories high on the south side and three stories high on the street side. It had a post-and-lintel frame with steel-pipe columns, rolled-steel beams and concrete floor slabs on steel joists. Walls were unreinforced hollow concrete block. The building was sheared in an east-west direction at the third-story level on the south side and in the lower two stories on the north side—the upper stories lurched west relative to the lower stories” (Hansen, 1965, p. A25–A26; fig. 23). Although built on a bluff, there was no landsliding here; the building was damaged as a result of ground shaking alone.

Figure 23. View looking northeast of the Hillside Apartment Building, Anchorage, Alaska. The adjacent white wood-framed house received little damage and is standing at the present day (2014). (Photograph from U.S. Geological Survey Photographic Library, ID aeq00021.)

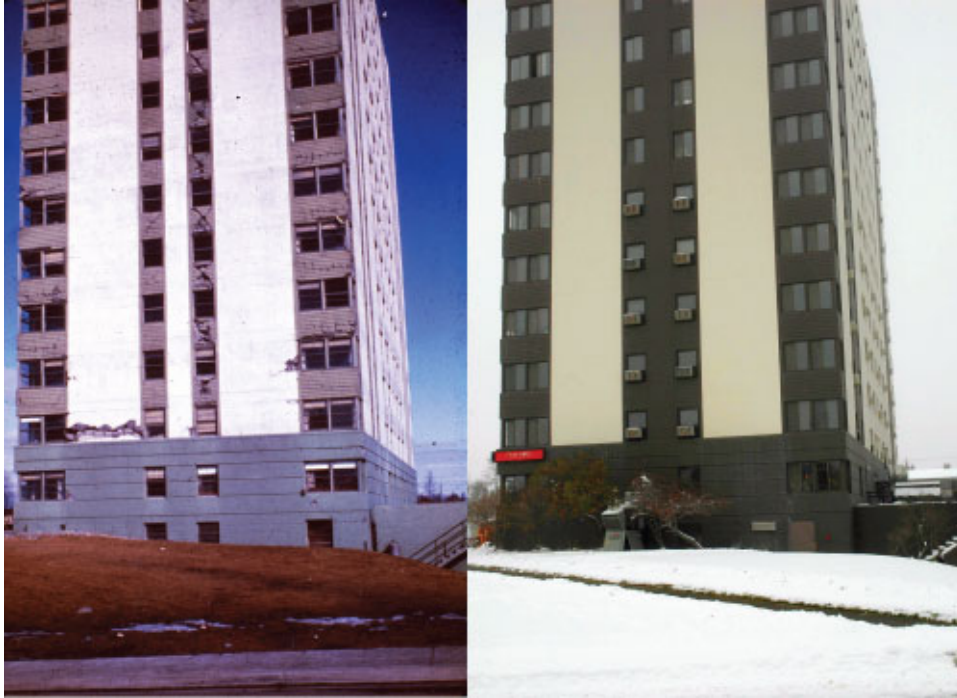
The Inlet Tower was moderately damaged because of ground shaking (fig. 28) in much the same way as its twin, the McKinley Tower (Stop 6; Hansen, 1965, p. A26).

Figure 28. Comparison photographs of the Inlet Tower taken from the same location on 13th Avenue. (Left photograph [1964] from U.S. Geological Survey Photographic Library, ID aeq00019; right photograph [2013] taken by R.G. McGimsey, U. S. Geological Survey.)

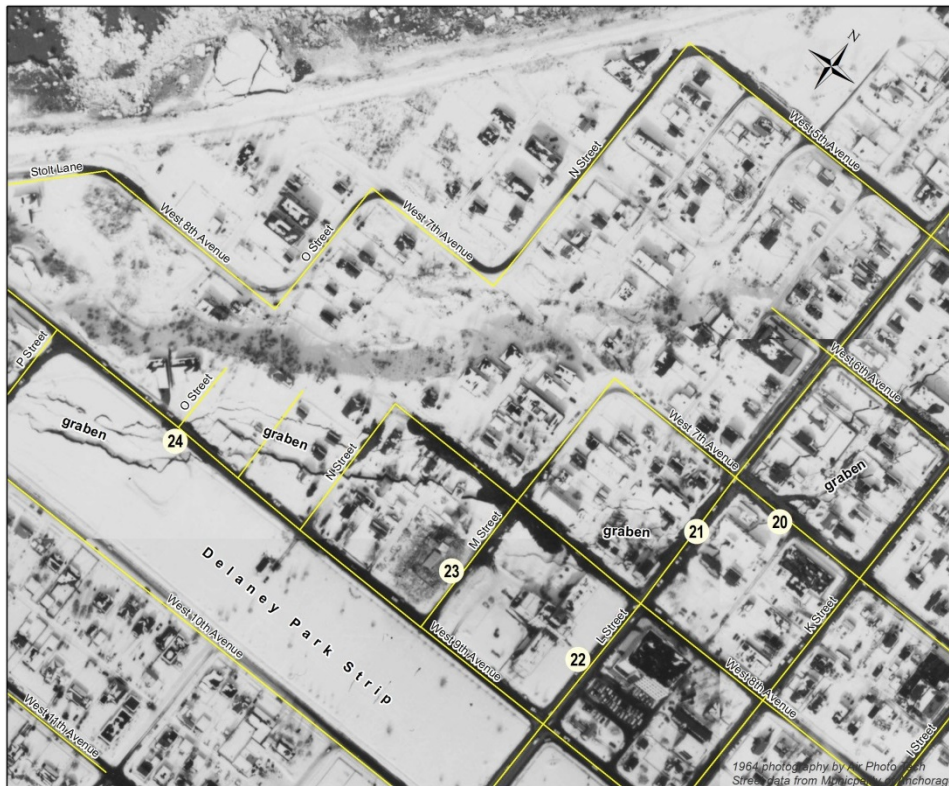
Perhaps the most notable feature of the L Street Slide was the long arcuate graben that formed at its head (fig. 29). It was concave toward the shoreline, about 3,600 feet long, with a maximum width of about 250 feet (Hansen, 1965, p. A43). There were fractures on both sides of the graben and pressure ridges at the toe of the slide which were damaging, but much of the slide mass showed little disturbance despite moving toward the shoreline at distances of up to 14 feet (Hansen, 1965, p. A43). Much of the damage occurred at the graben where the ground under foundations subsided as much as 10 feet (Hansen, 1965, p. A43), as it did underneath the apartment building in figure 30.

**Figure 29.** Annotated aerial photograph of most of the area affected by the L Street Slide, Anchorage, Alaska. Photographic tour stops are marked by number: (20) 715 L Street Apartment Building, (21) L Street Bend, (22) St. Mary's Residence, (23) Four Seasons Apartment Building, and (24) L Street Slide scarp. (Photograph taken by Air Photo Tech, 1964.)

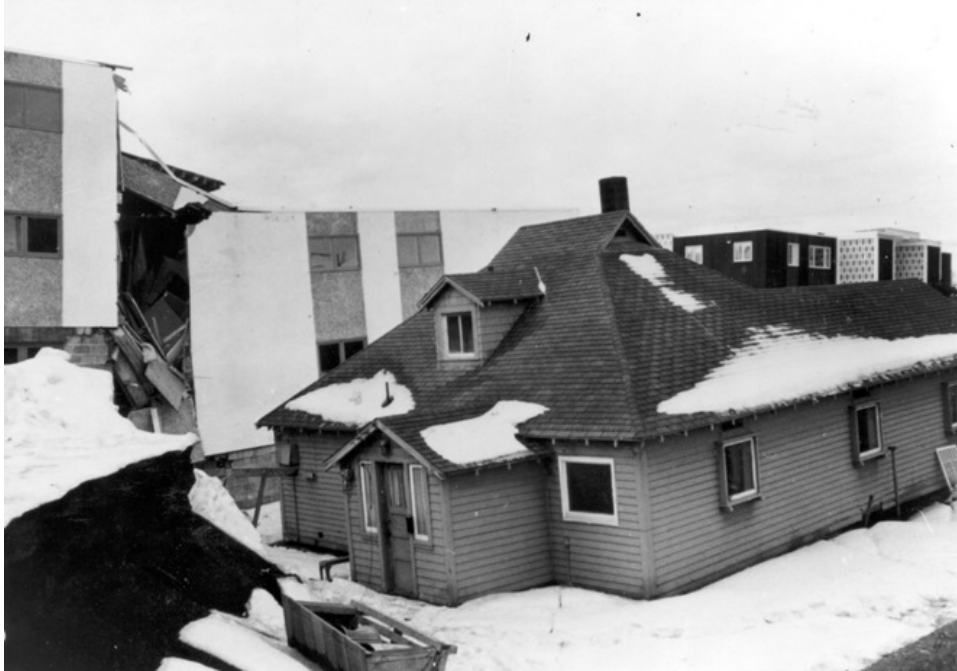
**Figure 30.** The apartment building behind the largely undamaged house in the foreground was sheared almost equally in two when the western half dropped 7 feet down the main scarp at the head of the L Street Slide, Anchorage, Alaska, 1964. The apartments have been removed but the Anchorage Medical and Surgical Building to the east was undamaged. (Photograph from U.S. Geological Survey Photographic Library, ID ake00327.)

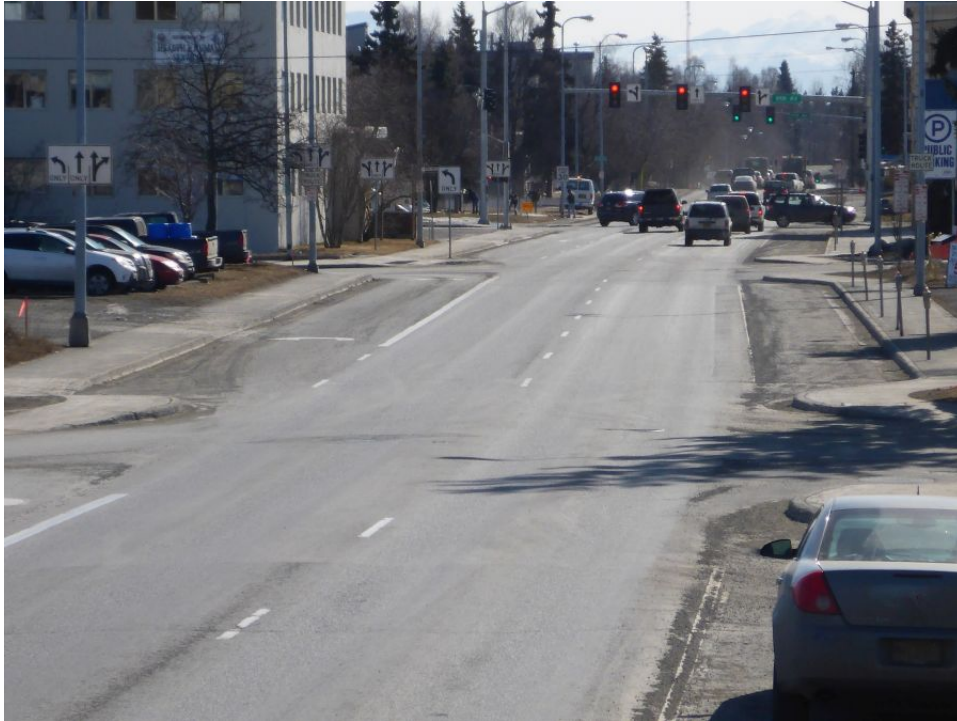
**Figure 31.** View looking south down L Street from a just south of 6th Avenue, Anchorage, Alaska. The two subtle but distinct kinks in the centerline, as it is traced from lower left toward the upper right, represent the re-alignment of L Street where it crossed the main scarp at the head of the L Street Slide. (Photograph taken by Evan Thoms, U.S. Geological Survey [2014].)
