# 1964 Great Alaska Earthquake—A Photographic Tour of Anchorage, Alaska

Open-File Report 2014–1086

By Evan E. Thoms, Peter J. Haeussler, Rebecca D. Anderson, and Robert G. McGimsey

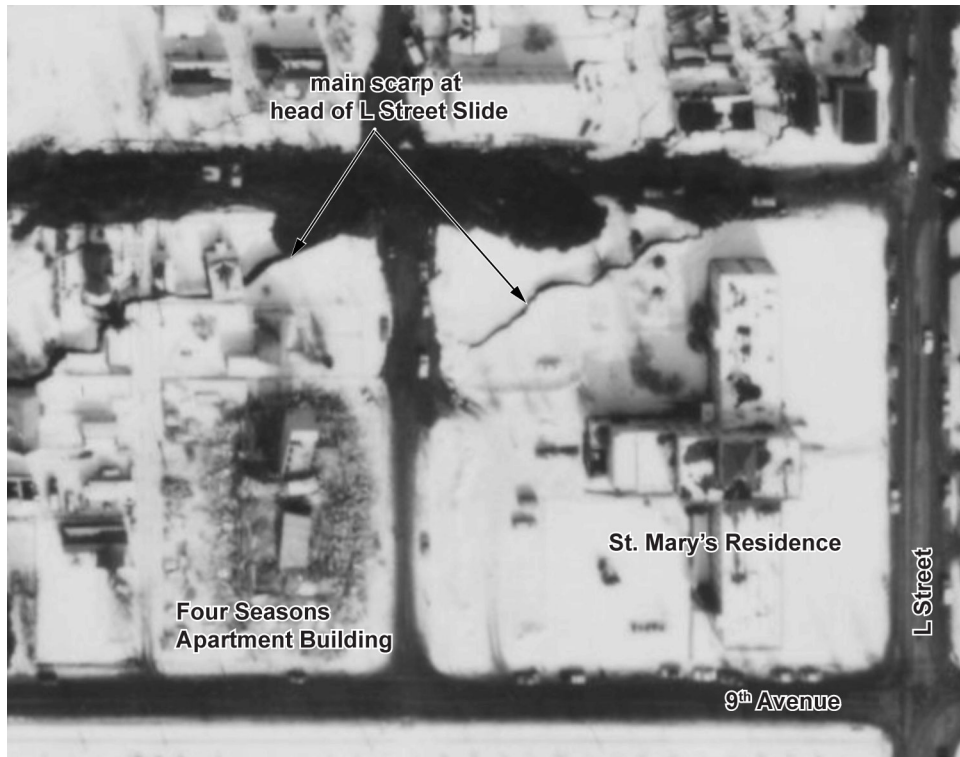
Completed in 1939, the original Providence Hospital became a nursing home known as St. Mary's Residence in 1962 and was a well-known landmark at the time of the earthquake. Despite its proximity to the graben that formed at the head of the L Street Slide (fig. 32), the building survived the earthquake with minimal damage and remained in use until it was demolished in the mid-1970s.

Figure 32. 1964 aerial photograph of St. Mary's Residence and the nearby Four Seasons Apartment Building (Stop 23), Anchorage, Alaska. (Photograph taken by Air Photo Tech, 1964.)

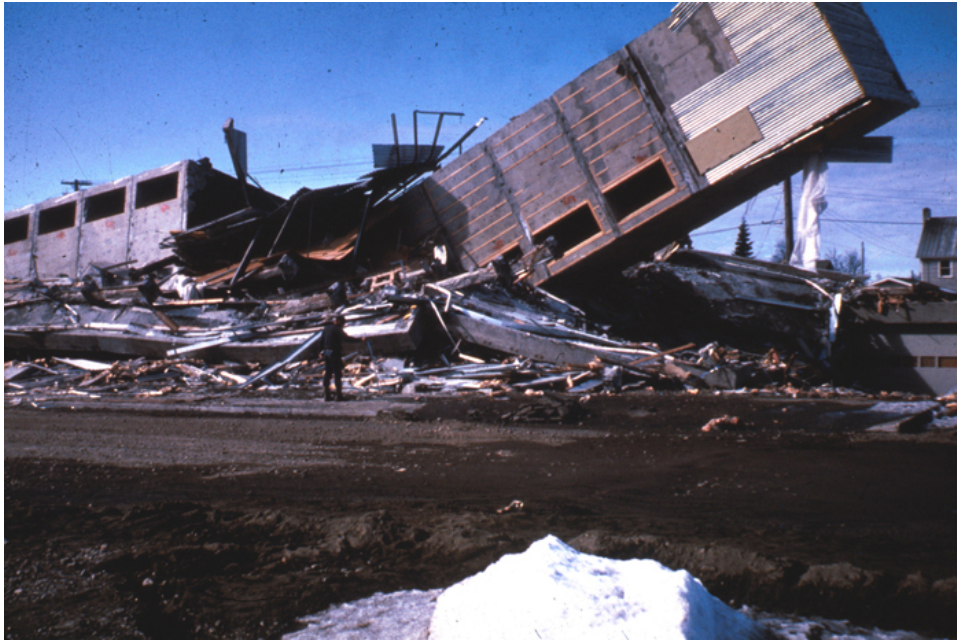
The Four Seasons Apartment Building was a new 6-story lift-slab reinforced concrete building nearing completion in 1964 (fig. 33). It reportedly withstood 2–3 minutes of shaking before collapsing just before the end of the earthquake. The main shear-resistant structural elements of the building, a poured-in-place reinforced concrete stairwell and a combined elevator shaft and stairwell, fractured at the first floor, toppled over, and came to rest on top of building rubble, all the while remaining largely intact (Hansen, 1965, p. A24–A25).

**Figure 33.** The remains of the Four Seasons Apartment Building, Anchorage, Alaska, 1964. The tilted column on the right was the combined elevator shaft and stairwell. (Photograph from U.S. Geological Survey Photographic Library, ID aeq00026.)

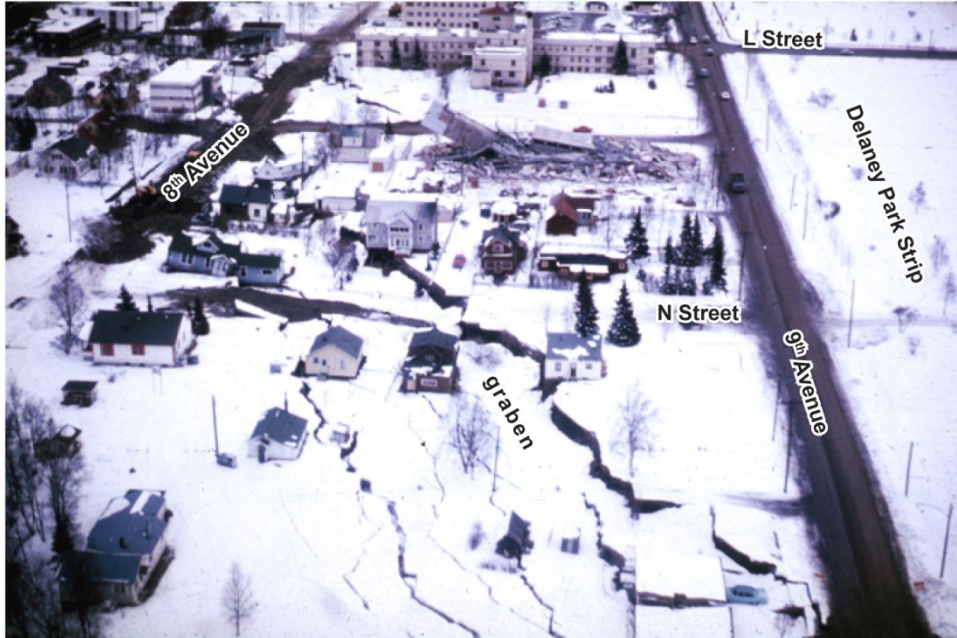
At this location, the graben at the head of the L Street Slide cut across 9th Avenue and continued to the southwest across the Delaney Park Strip (fig. 34). The degraded main scarp is visible today as the small rise in slope to the east between here and the Centennial Rose Garden.

**Figure 34.** In this annotated view looking east, the graben at the head of the L Street Slide, Anchorage, Alaska, 1964 cuts through properties between 8th and 9th Avenues from upper left to lower right. The collapsed Four Seasons Apartment Building (Stop 23) and the relatively undamaged St. Mary's Residence (Stop 22) lie beyond the graben on undisturbed ground. The present-day Centennial Rose Garden is just off the right margin of this photograph, near the N Street easement. (Photograph from U.S. Geological Survey Photographic Library, ID aeq00043.)

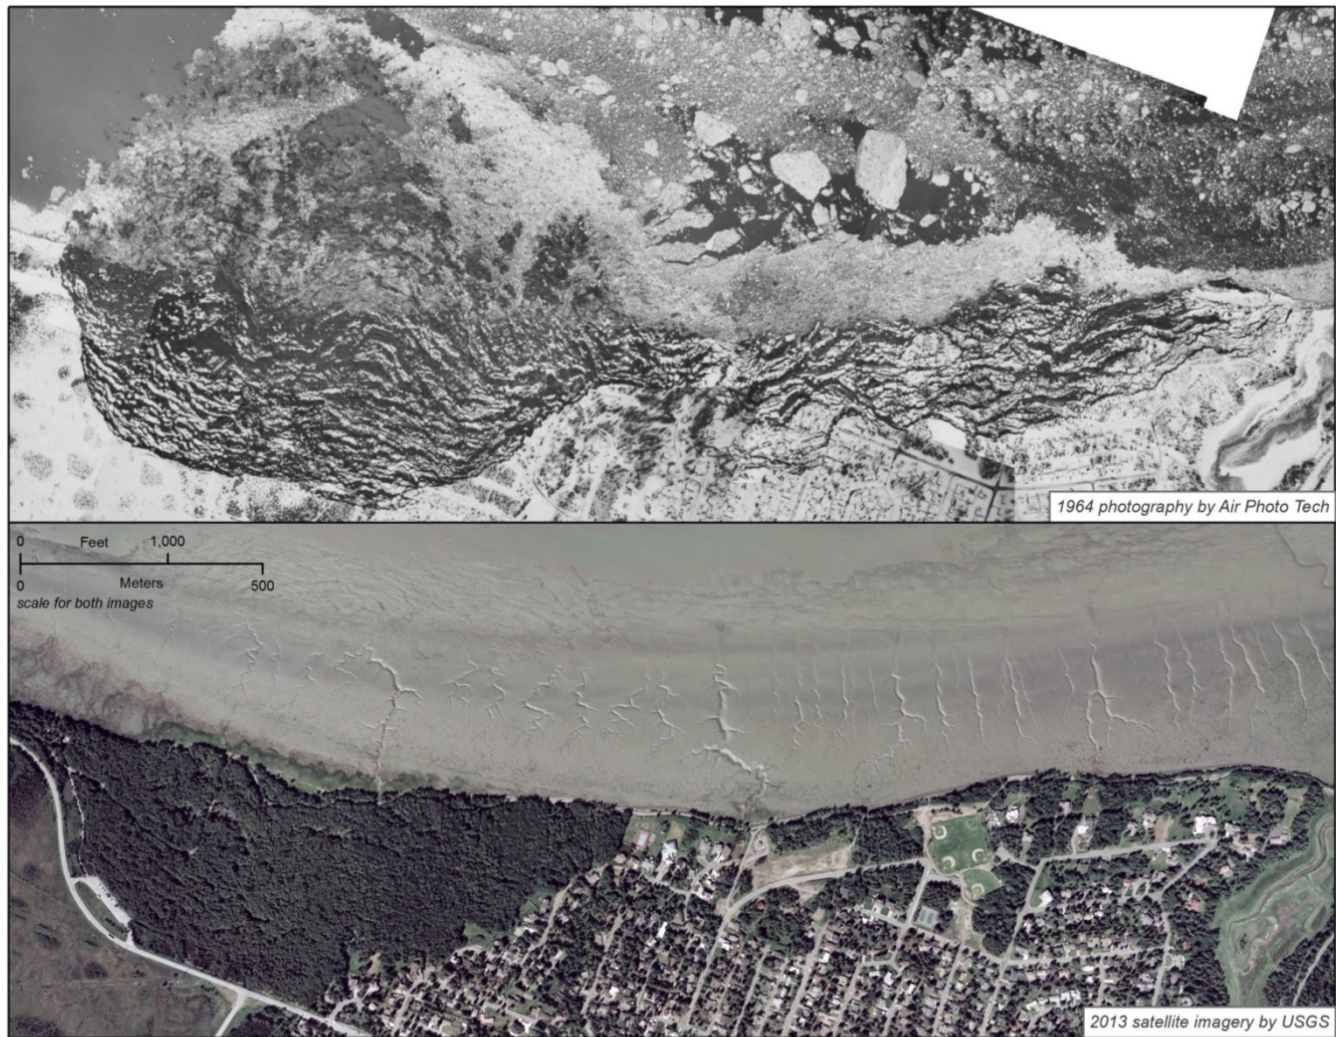
The Turnagain Heights Slide occurred along a steep bluff fronting Knik Arm on Cook Inlet. Its length east to west, parallel to the former shoreline, was about 1.5 miles, and the bluff retreated southward a maximum of 1,200 feet into the Turnagain Heights neighborhood (fig. 36; Hansen, 1965 p. A59). In all, about 130 acres were completely disrupted and 75 homes were reportedly destroyed (Hansen, 1965, p. A59; figs. 36–41). Failure here and in the L Street, 4th Avenue, and Government Hill landslides in Anchorage occurred on horizontal or near horizontal slip surfaces in a sensitive clay facies of the underlying Bootlegger Cove Formation, prone to cyclic softening (Hansen, 1965, p. A65). The Tony Knowles Coastal Trail passes along the toe of the slide mass, where relics of the disturbed ground surface are still visible near Earthquake Park, just north of the Ted Stevens Anchorage International Airport.

**Figure 36.** 1964 photo-mosaic showing the extent of the Turnagain Height Slide (top) and 2013 satellite imagery (bottom) for comparison, Anchorage, Alaska. A portion of the area covered by the landslide has been turned into parks, but the rest remains residential in use. (Top photograph taken by Air Photo Tech, 1964; bottom satellite imagery by U.S. Geological Survey, 2013.)

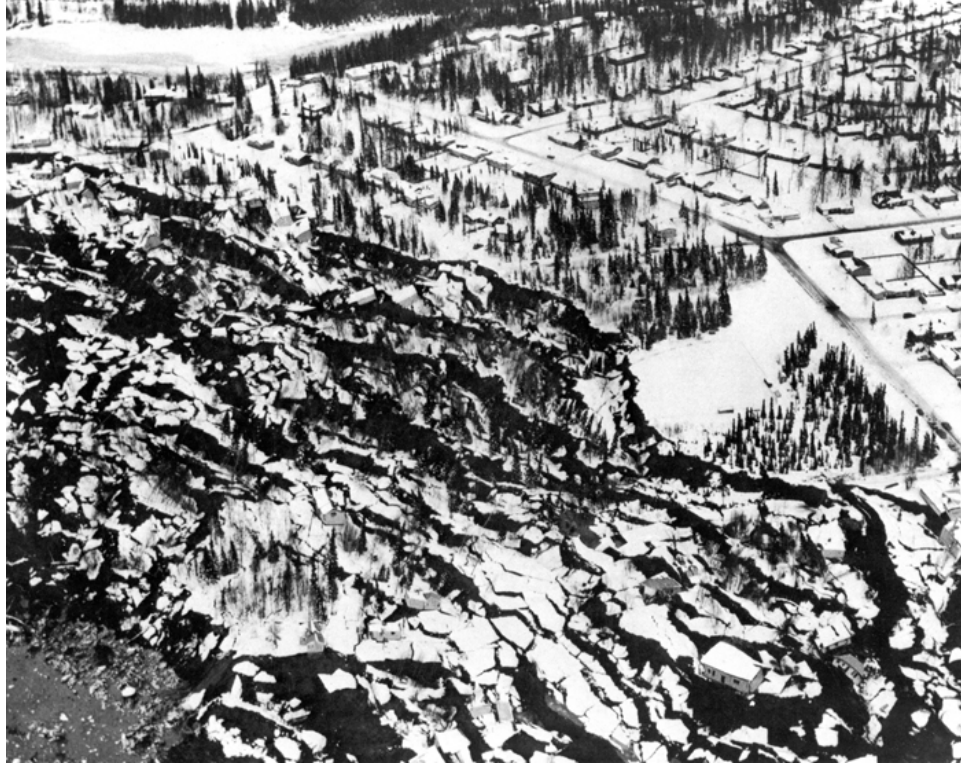
**Figure 37.** View of part of the Turnagain Heights Slide looking roughly southeast shortly after the earthquake, Anchorage, Alaska, 1964. (Photograph from U.S. Geological Survey Photographic Library, ID ake00087.)

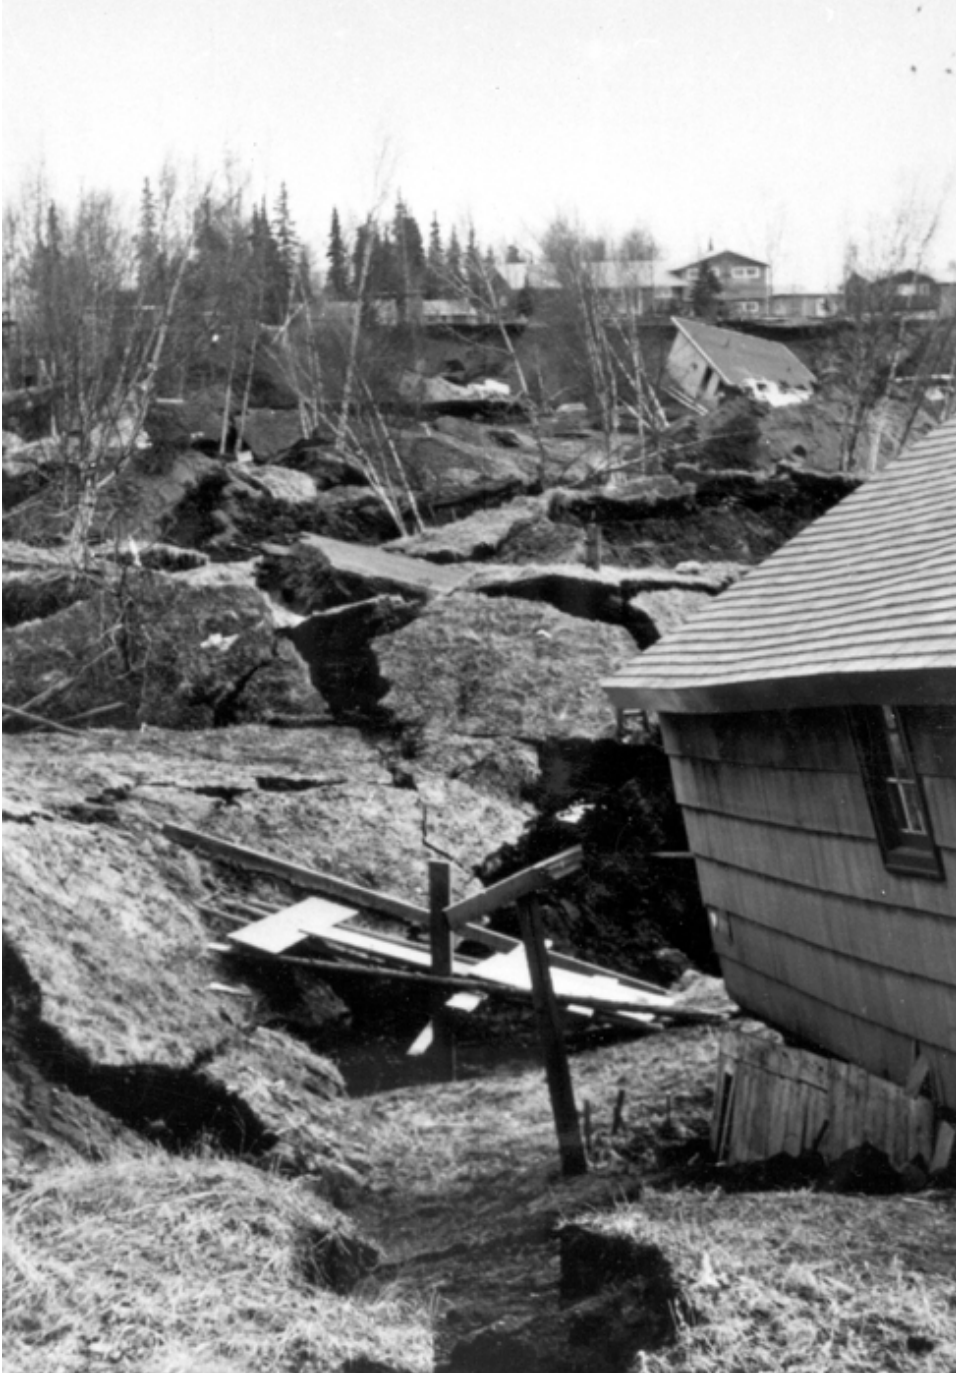
**Figure 38.** View from within the Turnagain Heights Slide mass looking roughly south, Anchorage, Alaska, 1964. Note the structures on the new bluff in the background. The ground surface was lowered about 35 feet from the pre-quake level. After the earthquake this area was regraded and gradually redeveloped with single-family residences. (Photograph from U.S. Geological Survey Photographic Library, ID eib00337.)

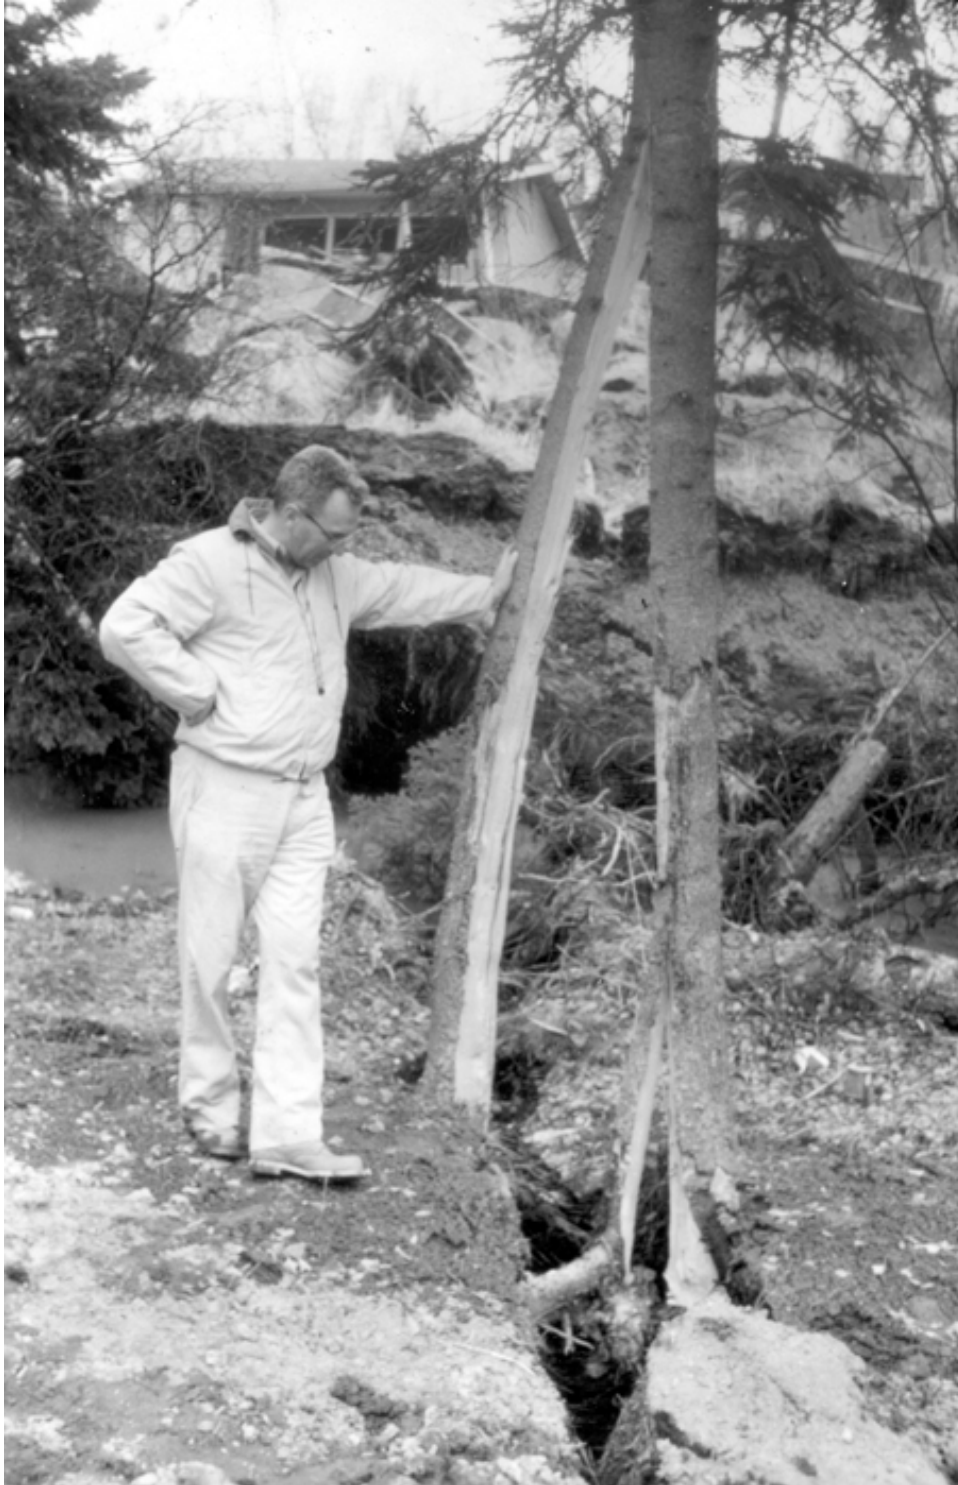
**Figure 39.** Tree split in half by a crack in frozen ground near in the Turnagain Heights Slide area, Anchorage, Alaska, 1964. (Photograph from U.S. Geological Survey Photographic Library, ID ake00070.)

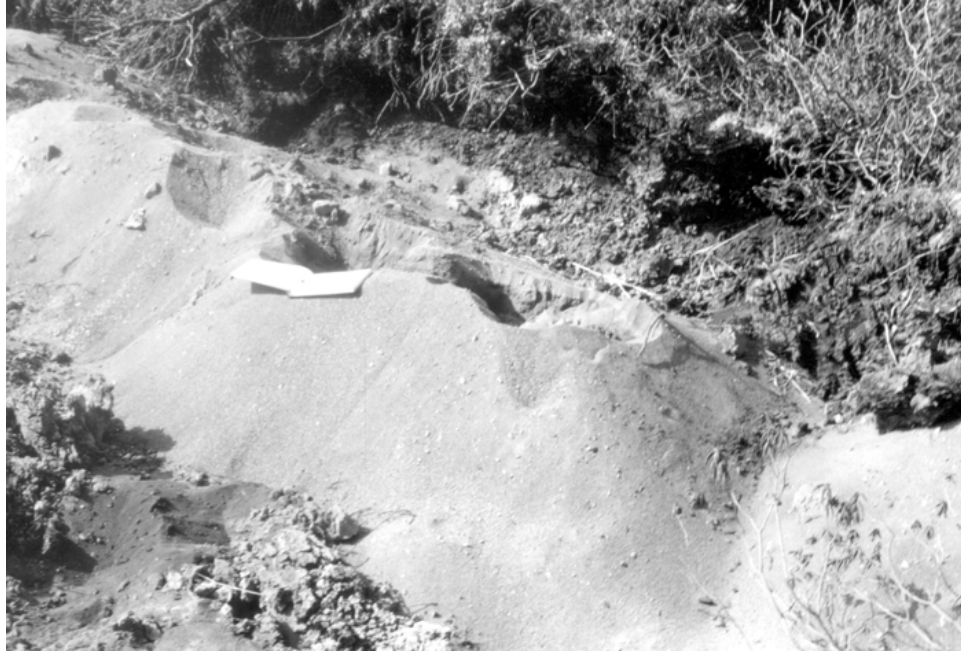
**Figure 40.** Part of a sand boil in the Turnagain Heights Slide area, Anchorage, Alaska, 1964. Ridges 2–3 feet high and 100 feet or more long were formed as fountains of water ejected through frozen ground. (Photograph from U.S. Geological Survey Photographic Library, ID ake00060.)

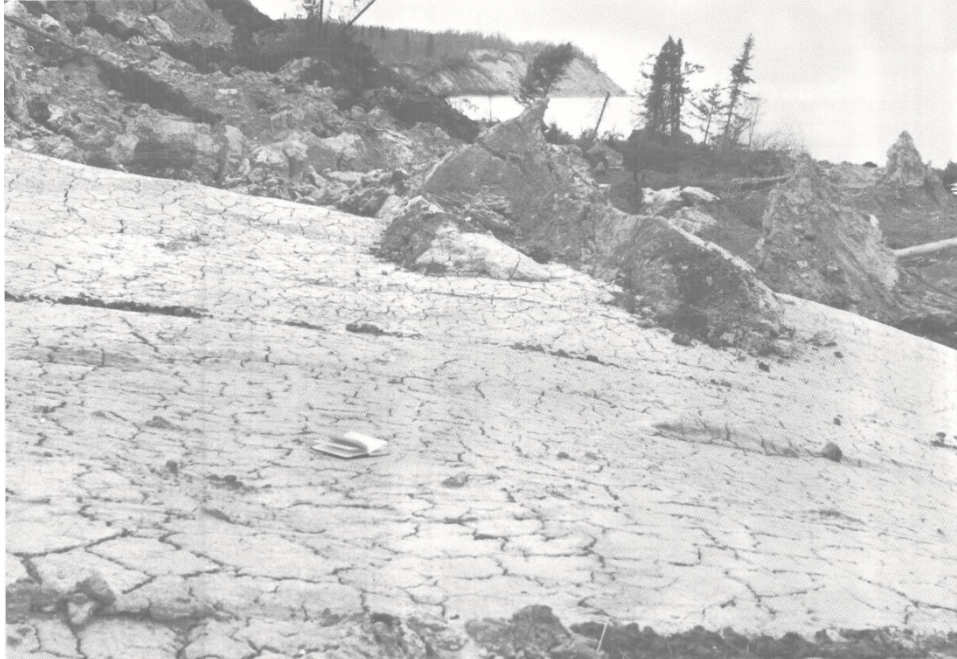
**Figure 41.** Slip surface in the Bootlegger Cove Formation exposed near the west margin of the Turnagain Heights Slide, Anchorage, Alaska. View is roughly to the west with Point Woronzof in the distance. (Photograph from Hansen, 1965, fig. 43, p. A63).

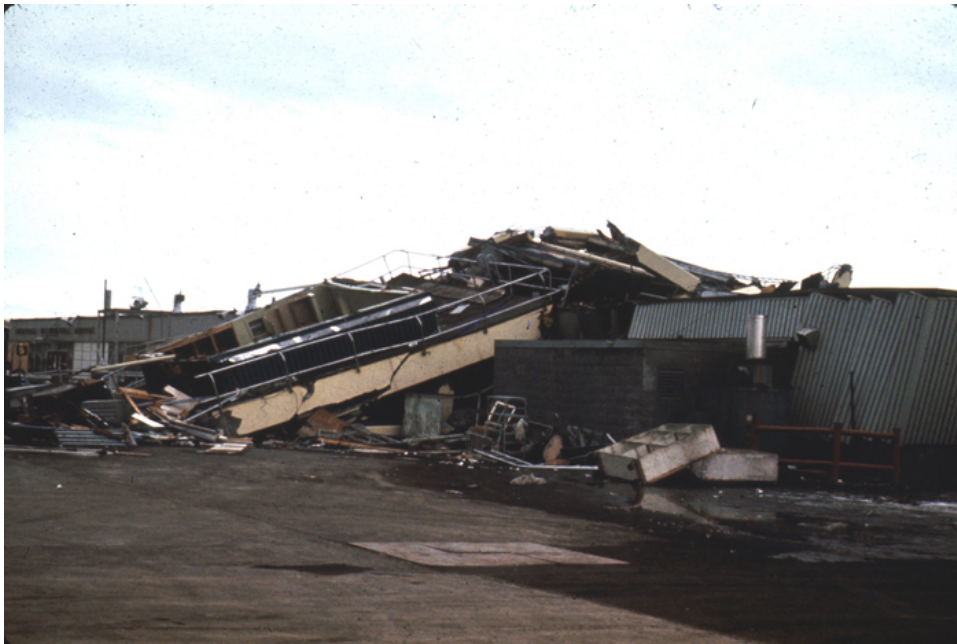
**Figure 42.** The destroyed control tower at the Anchorage International Airport, Anchorage, Alaska, 1964. (Photograph from U.S. Geological Survey Photographic Library, ID aeq00027.)
