# 1964 Great Alaska Earthquake—A Photographic Tour of Anchorage, Alaska

Open-File Report 2014–1086

By Evan E. Thoms, Peter J. Haeussler, Rebecca D. Anderson, and Robert G. McGimsey

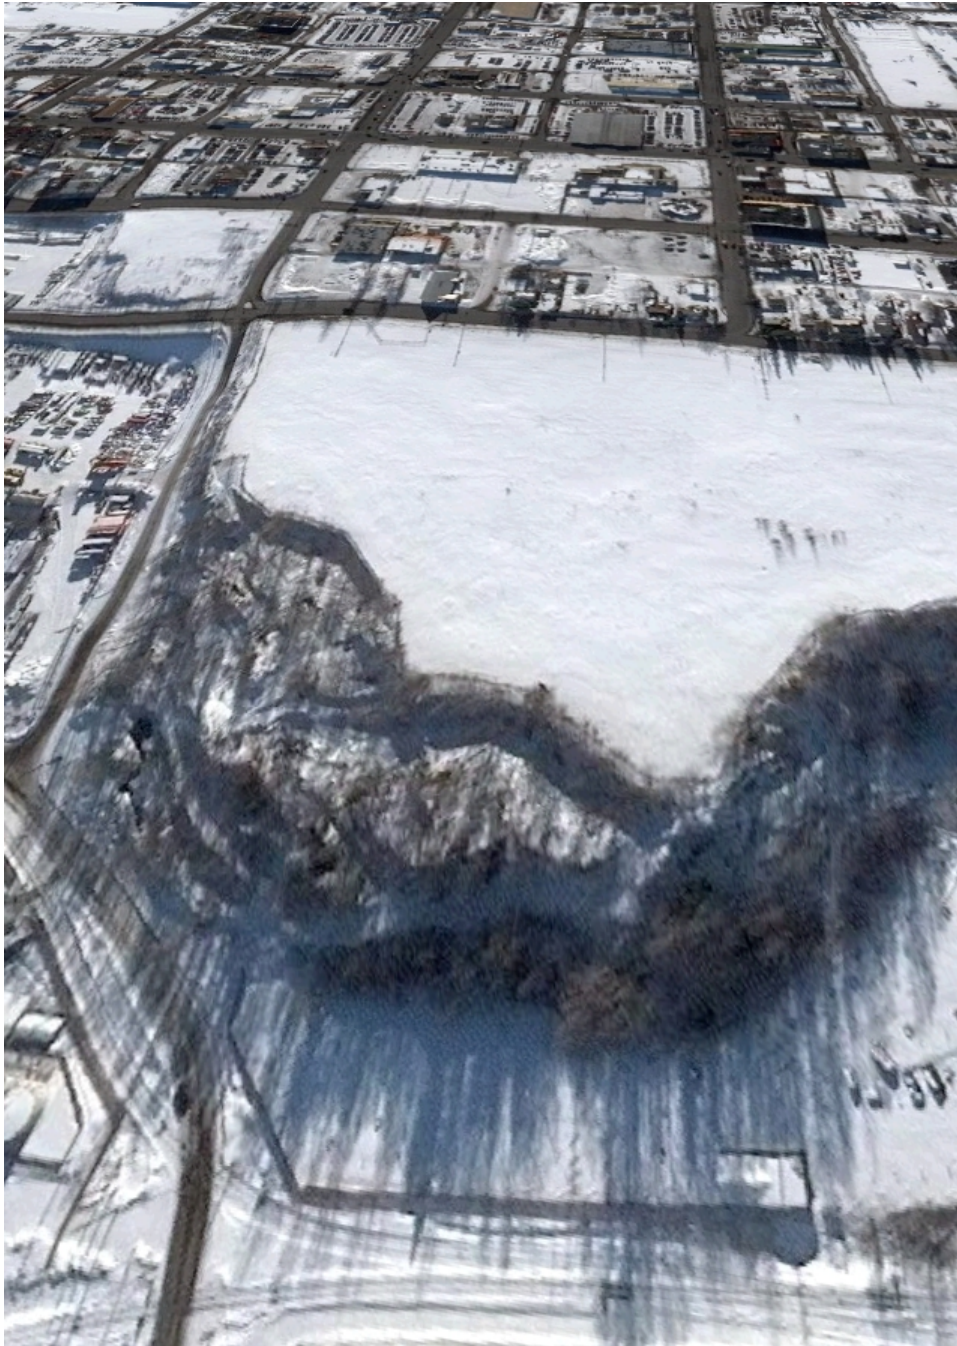
The hospital remained in service until the occupation of a new building in 1997 and was demolished shortly thereafter (Rife and Dellapenna, 2009). The scars of both the 1964 landslide and the undated landslide before 1964 are visible at the present day (2013) (fig. 7).

**Figure 7.** Re-creation of the view south of the Native Hospital Slide and the former Alaska Native Service Hospital from satellite imagery and 2011 lidar elevation data, Anchorage, Alaska. (Satellite imagery from 2014, ©Digital Globe, NextView License; 2011 lidar data from Federal Emergency Management Agency, project number 400000072.)

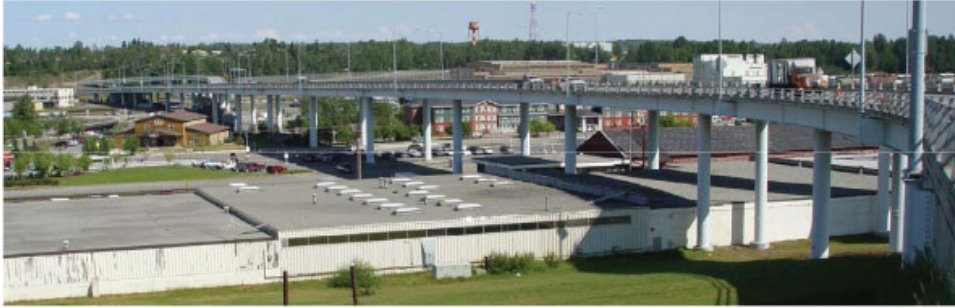
In an effort to understand more about how bridges react to earthquakes, the Port Access Bridge, constructed in 1975 and retrofitted through the years, was instrumented with accelerometers beginning in 2003 (Yang and others, 2004; Yang, 2006). In all, 39 sensors along its length record earthquake- and train-induced vibrations and collect data used by scientists and engineers (Yang, 2006).

Figure 13. View looking north from Buttress Park of the Port Access Bridge (photograph from Yang, 2006, p. 4), Anchorage, Alaska. Accelerometers are installed near the tops of many of the support columns.

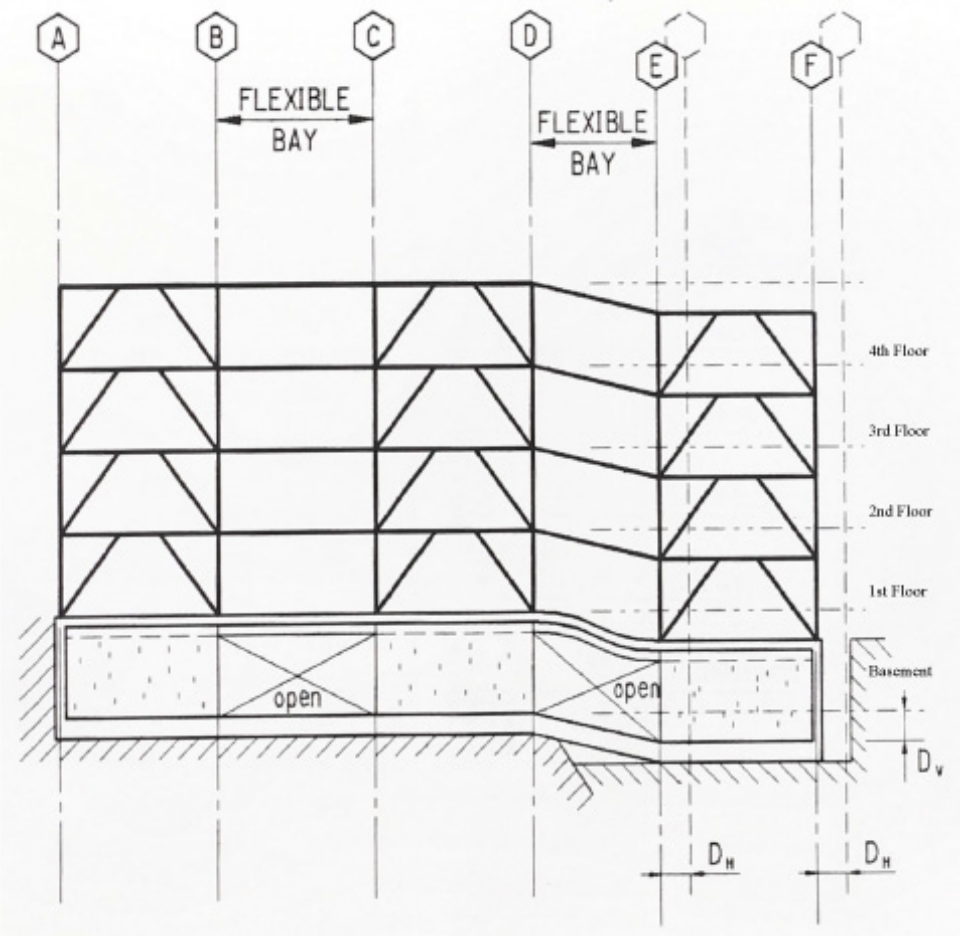
The Nesbett Courthouse is a 6-story building designed according to the 1991 Uniform Building Code and constructed in the mid-1990s. The site lies within Anchorage's Seismic Hazard Zone 4, which means it has a “high” potential for earthquake-induced ground failure. The building was designed to fail in a controlled way in order to accommodate ground displacements up to 4 feet horizontally and almost 3 feet vertically (fig. 24). The main structural support for the building is on steel beams, girders, and columns bearing on a continuous 3-foot thick reinforced concrete slab foundation. Wind and seismic forces (that is, lateral loads on the building) are resisted by a dual system of eccentric braced frames and special moment frames. These lateral loads are transmitted to the slab foundation through concrete shear walls in the basement. The predicted lateral and vertical displacements during a major earthquake-induced landslide were designed to be taken up by rotation and deflection within unbraced sections of the building frame, or “flexible bays,” in order to avoid complete collapse. Figures 25 and 26 are examples of the structural and foundation details in the construction plans for this building.

Figure 24. Simplified diagram showing how the Nesbett Courthouse is meant to accommodate ground motion below or beside the foundation without collapsing completely (Coffman Engineers, Inc., 1987). Unbraced “flexible bays” are designed to take up displacements ( $D_H = 4$  feet,  $D_V \approx 3$  feet) while allowing other sections of the building to remain intact. Letters A-F are reference names for the sides of the frames in the building.  $D_H$  and  $D_V$  are the vertical and horizontal, respectively, projected displacement due to landsliding.

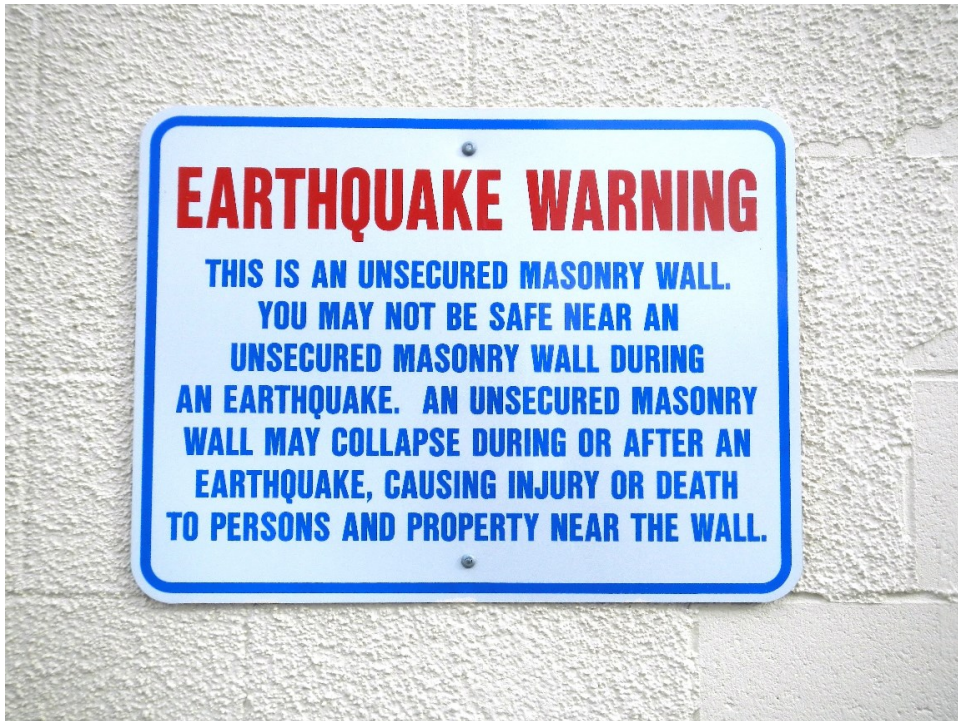
Unreinforced masonry walls consist of brick, concrete block, or other masonry material that is stacked and mortared without steel reinforcement, such as a grid of rebarthem. Although most unreinforced masonry structures in Anchorage fared well during the earthquake (Hansen, 1965, p. A23), they are of great concern worldwide because of the high rate of injury and property damage caused by their collapse during earthquakes (Reitherman, 2009; fig. 27). Retrofitting of existing buildings, however, is expensive and not required by most municipalities.

**Figure 27.** Signs along a wall adjacent to a parking lot warn motorists and passersby about the hazard presented by unreinforced masonry walls, Anchorage, Alaska. (Photograph courtesy of Robert Scher, Anchorage Geotechnical Advisory Commission [2013].)

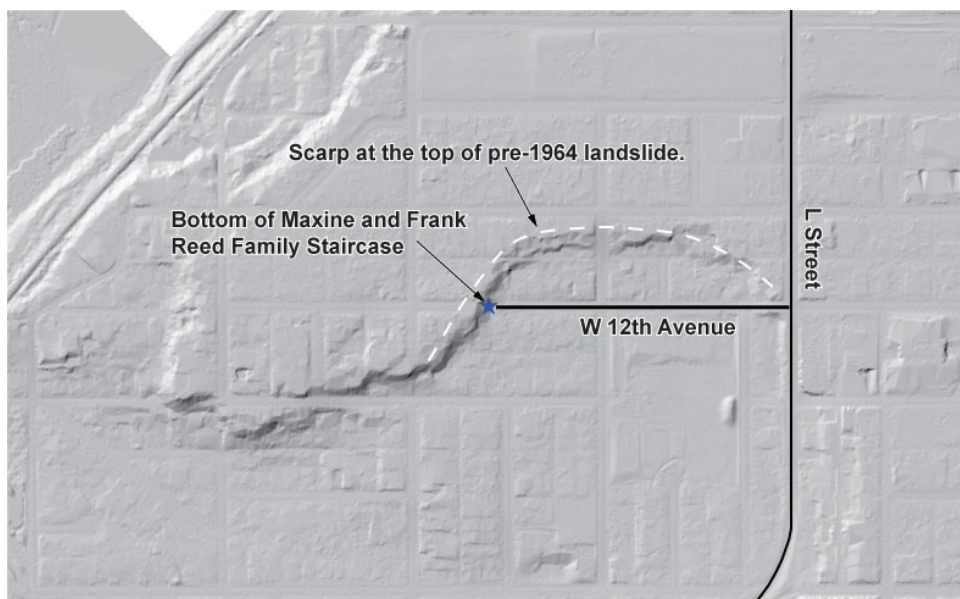
The staircase at this stop (named in 2007 in honor of the philanthropic residents who lived at the top of the staircase for more than 60 years) was built to accommodate pedestrian traffic over a steep bluff that some (Hansen, 1965, p. A67; Schmoll and Dobrovoly, 1972) interpreted to be evidence of landsliding during a pre-1964 earthquake of unknown age (fig. 35). Similar steep and arcuate bluffs exist throughout the Anchorage area indicating that landsliding is a common process in this area. There was no reported sliding on this feature in 1964 (Hansen, 1965, p. A67).

**Figure 35.** Annotated lidar-based hillshade elevation model of the probable landslide scar in the South Addition neighborhood, Anchorage, Alaska. (2011 lidar data from Federal Emergency Management Agency, project number 400000072.)
